SYLWRAP Case Study

900mm Pipe Surface Restoration & Repair

An oil well in Argentina needed to repair and restore the surface profile of a badly corroded, ruptured 900mm steel pipe to keep the oil pumping

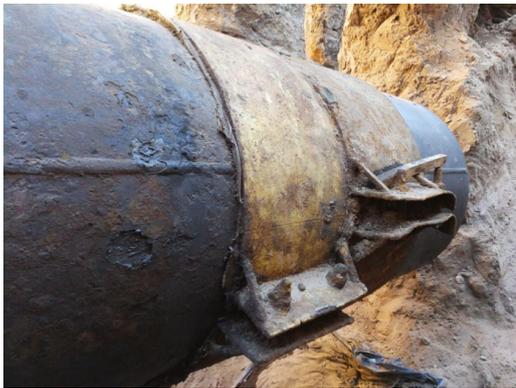
Initial repair attempted with two pipe clamps

An initial repair had been attempted with two pipe clamps. This was unsuccessful as the damaged area was located near a tee and welded joint. A more flexible repair method was required.

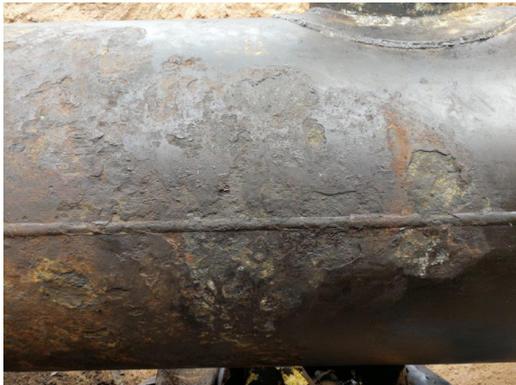
Pitting and ruptures caused to the 900mm pipe

Corrosion to the pipe had caused heavy pitting and ruptures. For the well to work efficiently, the pipe needed its surface profile restored and the ruptures to be sealed.

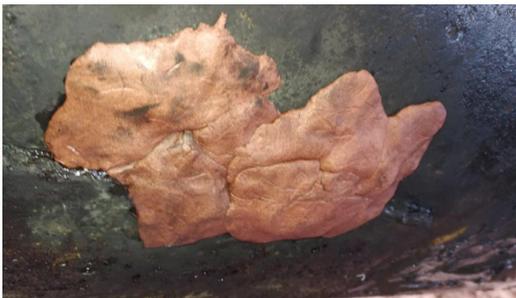
Superfast Copper plugged ruptures. It was then overwrapped with Wrap & Seal for reinforcement

Superfast Copper Epoxy Putty plugged the holes and smoothed off pitting. Because the pipe was oily, it was decided to increase the chemical and pressure resistance of the repair by using **Wrap & Seal Pipe Burst Tape** to reinforce the putty.

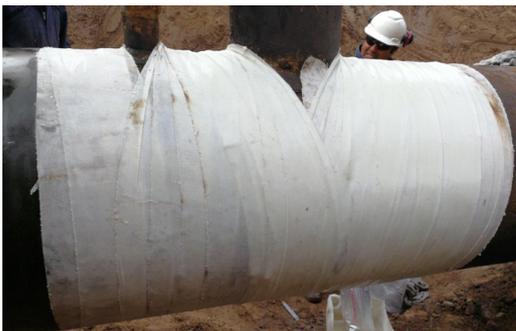
Several SylWrap HD Bandages provided further protection for a large section of the pipe

Multiple **SylWrap HD Pipe Repair Bandages** were then applied to the repaired section of the pipe, providing a rock-hard, protective shell from future corrosion and chemical attack.
