SYLWRAP Case Study

Welded Joint Leak Repair & Encapsulation

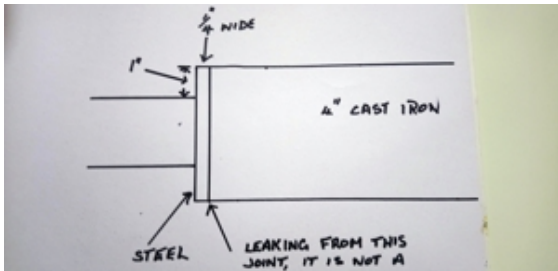
Repair diagram, showing the 50mm steel pipe, the 100mm cast iron pipe and the welded joint via plate

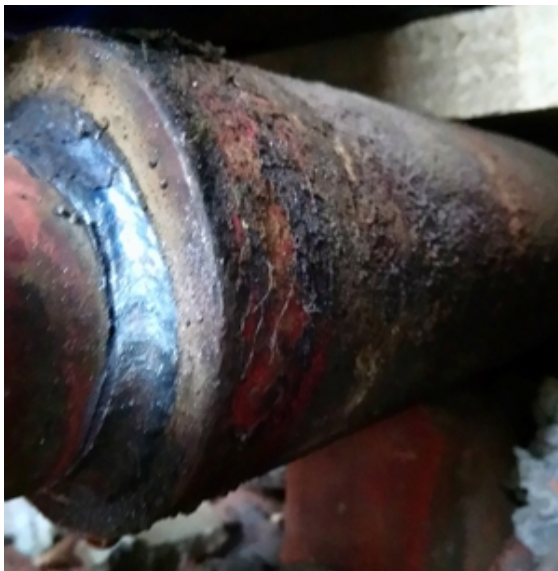
Corrosion had caused ruptures to the 100mm iron pipe where it was attached to the plate. More challenging were leaks caused by uneven welding near where the 50mm steel pipe was welded to the plate, whilst a threaded section of pipe close by was also leaking.

Corrosion to the 100mm pipe at the steel plate

Wrap & Seal Pipe Pipe Burst Tape was used to seal the first leak on the 100mm pipe. This was reinforced with **SylWrap HD** to protect the repair.

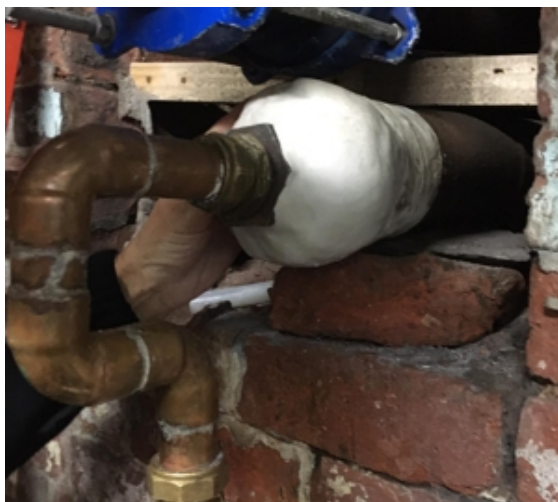
The completed repair with the pipe encompassed with Sylmasta AB Original

The 50mm pipe and the welded joint were sealed with **Sylmasta AB Original Epoxy Putty**. AB Original was used as its longer working time allowed a more thorough application of putty across the significant section of damage before curing.

AB Original encapsulated the whole section where the 100mm pipe, the 50mm pipe, and the steel plate had been welded together, filling in any imperfections and sealing all leaks.
