SYLWRAP Case Study

900mm Leaking Steel Water Main Flange Repair

A 900mm water main in an underground chamber flooded by water leaking from cracks around a flange undergoes an 'impossible' repair in Malaysia

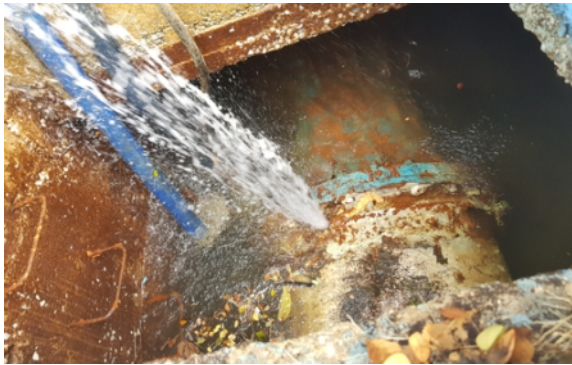
Pressurised water spraying from cracks in the main as the flooded chamber was drained before repair

Corrosion had caused cracks around a stub flange, through which water was escaping at high pressure. A clamp could not be fitted and there was no space between the water main and the ground to wrap tapes or bandages.

With no visible way of isolating the main, flow could not be shut off or reduced. The pipe was therefore considered impossible to repair and left to leak, flooding the chamber.

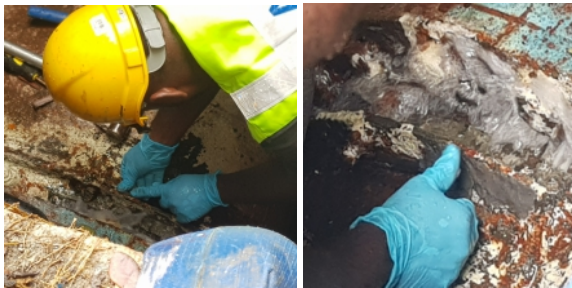
Superfast Steel filled the cracks in the pipe, fixed the plastic plugs in place and encompassed the flange

Water was pumped from the chamber. An engineer then hammered plastic plugs into sizable cracks along the flange, reducing the amount of water escaping to allow for a proper inspection.

A stopcock was spotted down the pipe. With flow turned off, **Superfast Steel Epoxy Putty** was used to fill in visible cracks and encompass the flange, permanently fixing the plugs in place.

The main was left for 24 hours. All remaining small leaks were sealed with more putty the next day, leaving one area needing attention where water was jetting from a gap between flange and pipe.

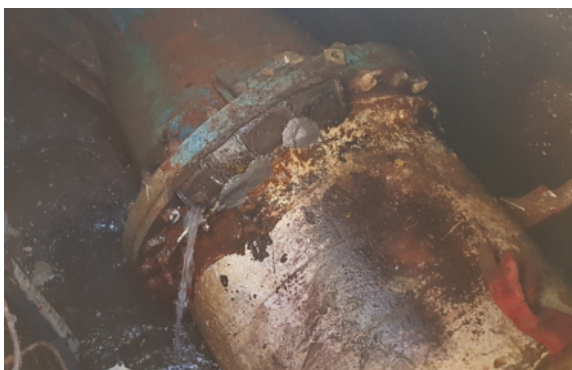
A valve was fixed in place with epoxy to channel water escaping through a gap between flange and pipe

To arrest this, the engineers used further Superfast Steel to fix a valve in place. Any water trying to escape would now be channelled to the valve.

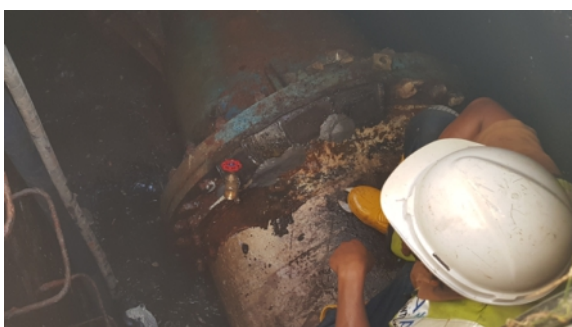
The 'impossible' repair completed with a tap fitted

The water company responsible for the main had originally wanted to reduce the amount of water being lost. Instead, the determined engineering company sealed the pipe, completing the 'impossible' repair over two days.
