# SYLWRAP Case Study

## Underground Steel Water Main Live Leak Repair

A 400mm carbon steel underground water main in the United Kingdom had been leaking for 15 years without a suitable repair method being found

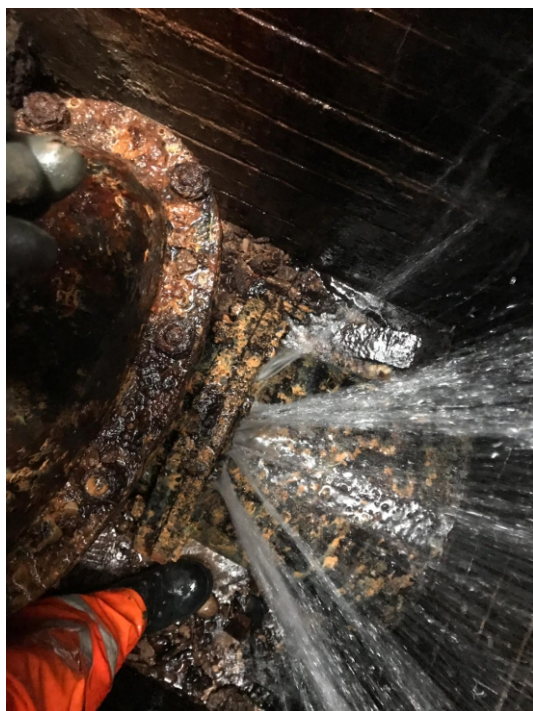
*The split in the 400mm carbon steel water main possessed a significant challenge*

The 400mm underground carbon steel water main had been leaking for 15 years from a split across its diameter. The main played a major role in a vital network and could not be shut off for a repair or a replacement.

The confined space meant there was no room for heavy machinery or repair clamps and only a single contractor could access the main at any one time.

**Wrap & Seal Pipe Burst Tape** was used to double wrap 400mm from the flange up the tapered pipe. Double wrapping compensated for the lack of room to stretch the Wrap & Seal by its full 300% which could have resulted in less-effective fusion.

The tape was overwrapped with several **SylWrap 416HD Pipe Repair Bandages**. This medium-sized wrap was chosen as the limited space would have made using a larger bandage difficult.

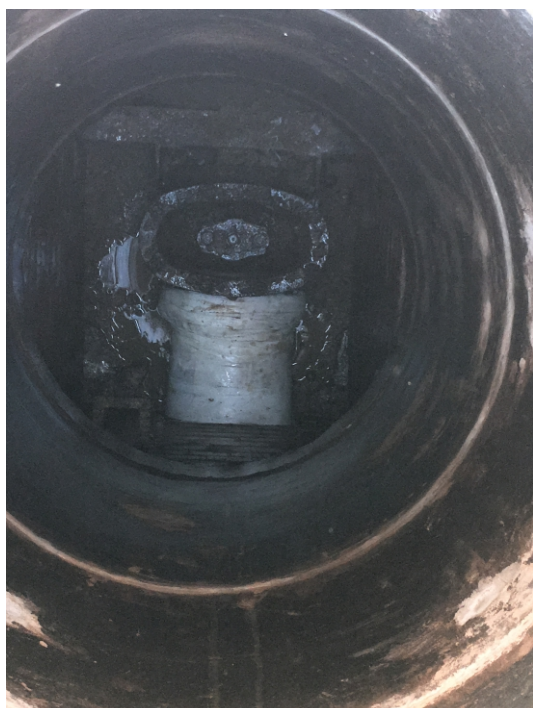
Within an hour, the water main had permanently sealed after a decade-and-a-half of being considered unreparable. No disruption to supplies were necessary.

*After 15 years, the burst water main was finally repaired thanks to Sylmasta*
