SYLWRAP Case Study

Cracked 90-year-old Malleable Iron Pipe Repair

With replacement fittings no longer made for a cracked 90-year-old pipe, a property owner sought a repair to avoid digging out their water supply line

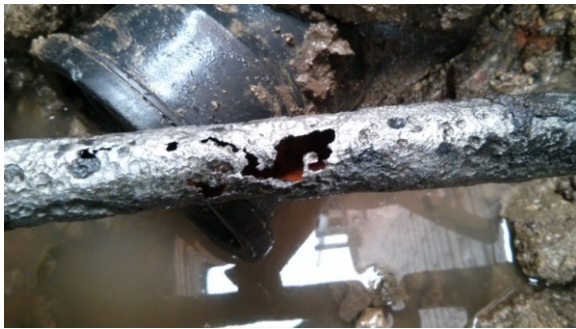
The larger crack in the malleable iron water supply pipe and several smaller holes surrounding the damage area

The 70mm malleable iron pipe connected the property to the public water supply. Excavation of the pipe revealed an awkward, number-9 shaped crack and several smaller holes.

The age of the pipe meant replacement fittings were no longer manufactured. The cracks and holes had to either be repaired, or the entire section would have to be dug out and replaced at considerable cost.

Small amounts of **Superfast Steel Epoxy Putty Stick** were kneaded by hand and pushed into the smaller holes.

For the large crack, Superfast Steel was formed into a disc shape larger than the crack. The disc was stretched over the entire damage area and the edges pushed down, forming a good seal with the surface of the pipe.

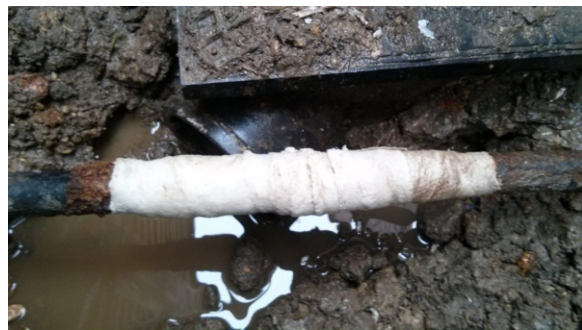
Completed repair wrapped in a SylWrap HD Pipe Repair Bandage before being re-buried

Once the putty had become firmer but not fully cured, a **SylWrap HD Pipe Repair Bandage** was wrapped around the repair, compressing the putty into any remaining gaps before curing to form an impact resistant protective sleeve.

Once the application was completed, the pipe was turned back on. No leaks were present and the pipe was re-buried.
