SYLWRAP Case Study

400mm GRP Pipeline Surface Damage Repair

Areas of external surface damage on a 400mm GRP line at an oil refinery are repaired to restore the integrity of the pipe and help prevent future leaks

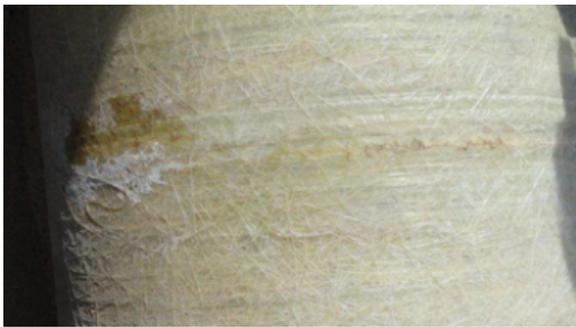
The external surface of the GRP pipe suffering from heavy scoring with the potential to lead to breaches

Construction work led to the excavation of an underground section of 400mm GRP pipe. The surface of the line was found to be damaged, with two areas suffering from heavy scoring.

Whilst the pipe remained accessible, the refinery decided to strengthen the line and restore its integrity by repairing the weakened areas.

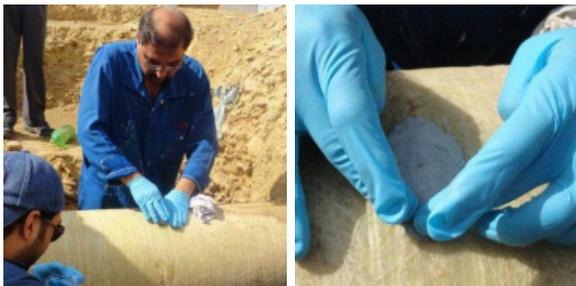
Superfast Steel was pushed onto the pipe to fill the imperfections in the line

Multiple **Superfast Steel Epoxy Putty Sticks** were used for the application. Superfast Steel was chosen because of its fast work time and the relatively small areas requiring repair.

Chunks of putty were cut from the sticks and kneaded by hand. Once the putty had turned a uniform colour to indicate successful mixing, it was pushed down onto the pipe and smoothed over the scored areas.

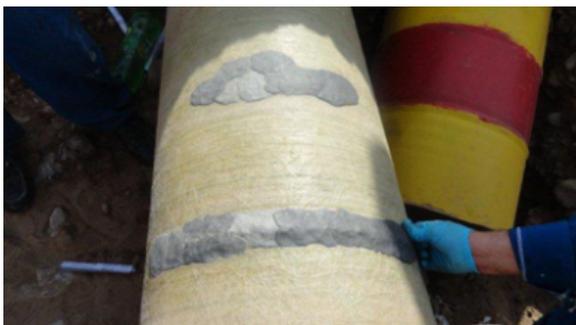
The putty cured to form a material hard as steel over the weakened areas

Within 10 minutes, the putty began to harden. Once fully cured, it permanently embedded into imperfections in the line, creating a new waterproof layer as hard as steel over the weakened areas.

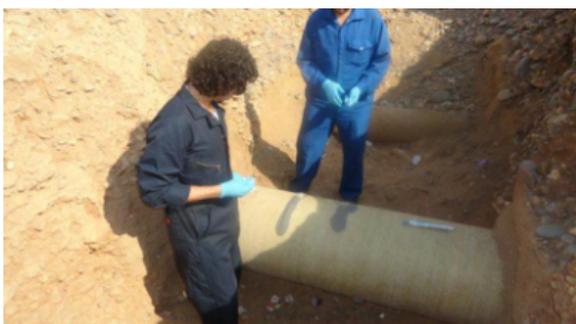
The completed repair with all damaged areas filled in. After completion, the pipe was buried again.

The entire repair took under two hours to complete. Once the construction work was completed, the line was again buried.

Several years later and the pipe had not been breached. Superfast Steel had done its job.
