# Rapid Epoxy Case Study

## Cracked Mortar and Pestle Repair

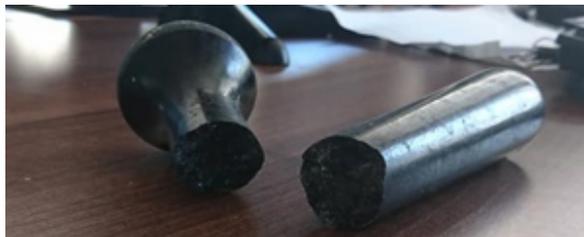
The pestle had cracked into two pieces when dropped

The granite pestle had been cracked into two when accidentally dropped onto a granite kitchen worktop. This left a break close to the base.

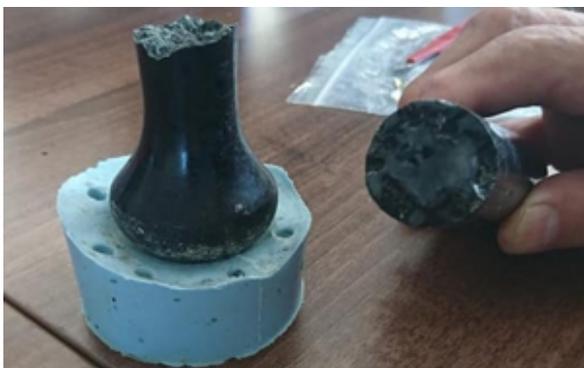
The bottom section was held in place with rubber. The top section was coated with Rapid 5 Minute

An even mix was achieved after 30 seconds and a thin layer of epoxy applied to the break on the top half of the pestle. The bottom part was held upright by a piece of rubber, and the two parts pressed firmly together by the owner.

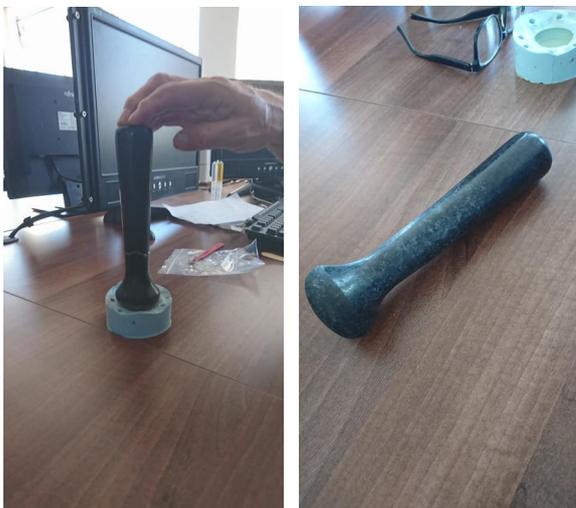
A high strength bond was created by pushing the two parts firmly together

After five minutes, bonding had begun to take effect. The owner no longer needed to press the parts together, instead leaving the pestle undisturbed for 30 minutes for the epoxy to reach maximum properties.

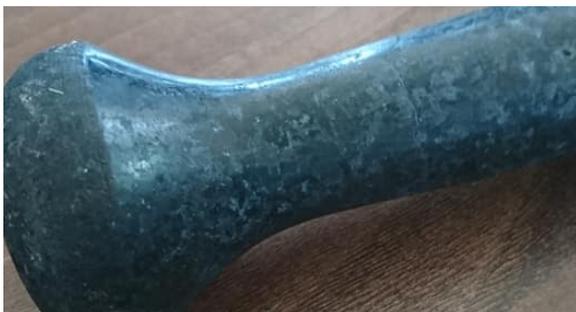
Rapid 5 Minute sets relatively clear, leaving no obvious glue lines or evidence of the crack. Several years later and the pestle still works perfectly.

The completed repair left no evidence of the crack
