SYLWRAP Case Study

Corroded Porth Pipe Bridge Refurbishment

A dilapidated pipe bridge crossing the Rhonda River in Porth is repaired and refurbished, saving Dwr Cymru Welsh Water from an expensive replacement

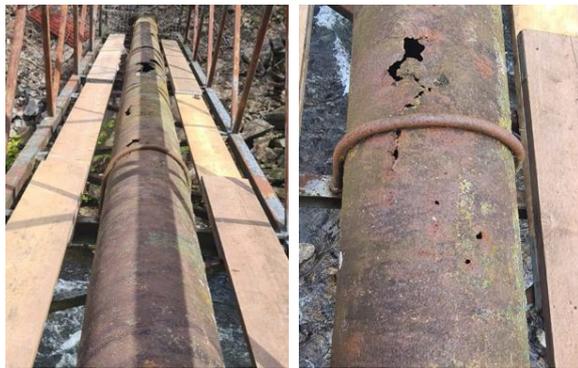
Corrosion had breached the pipe in several places

Dwr Cymru contacted Sylmasta for repair advice and appointed Arch Services as contractors. An inspection by Arch revealed the pipe to be covered in corrosion, leaving large holes in several places.

The holes were too big and the pipe too brittle to be repaired with putty, so Arch layered large fibreglass patches over the cracked sections to seal the leaks.

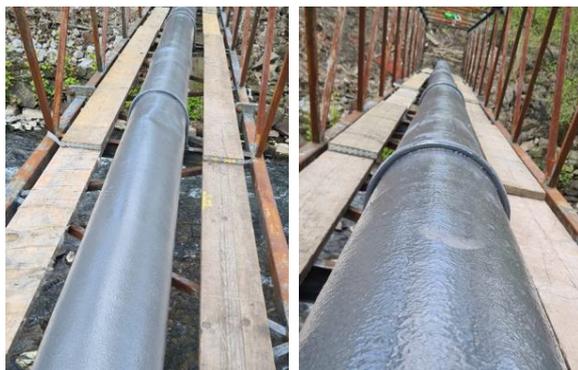
Liquid Metal was painted onto the pipe, curing to form a new, impermeable metallic outer surface

Several layers of **Liquid Metal Epoxy Coating** were then painted onto the pipe and the steel hoops and beams holding it in place, using a roller.

Once cured, Liquid Metal formed a hard-wearing, smooth, metallic, impermeable skin around the pipe. This new outer surface would prevent further corrosion and ensure fluids could no longer escape.

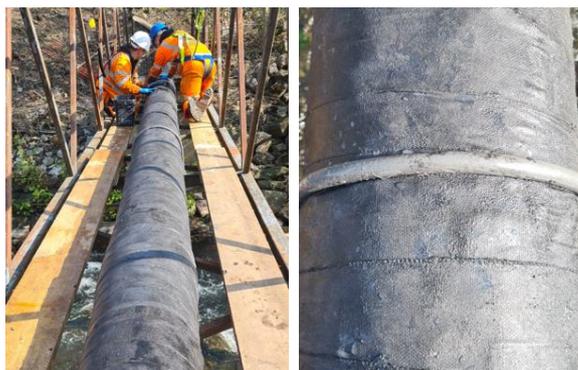
SylWrap CR was carefully applied to the whole line, providing further reinforcement and protection

To further reinforce the pipe and reinstate integral strength, the line was wrapped with four layers of **SylWrap CR Corrosion Protection Wrap**, which formed an impact-resistant protective shell.
