SYLWRAP Case Study

Encapsulation of Capped Pipe Stub at Landfill

A capped pipe in a decommissioned drainage system at a landfill site is encapsulated to protect it from corrosion and a potential leak of toxic leachate

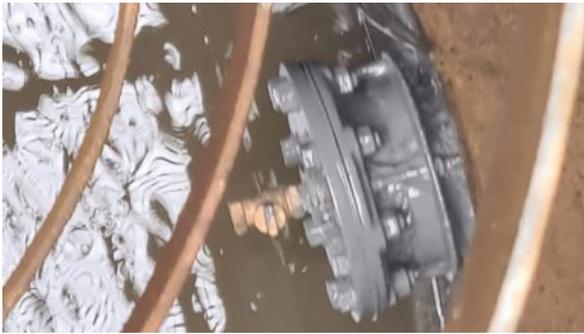
The stub needing encapsulation was difficult to access at the bottom of a chamber surrounded by metalwork

The stub protruded 300mm from a concrete wall towards the bottom of a chamber. There was little room to move and access was further restricted by various metal structures above the stub.

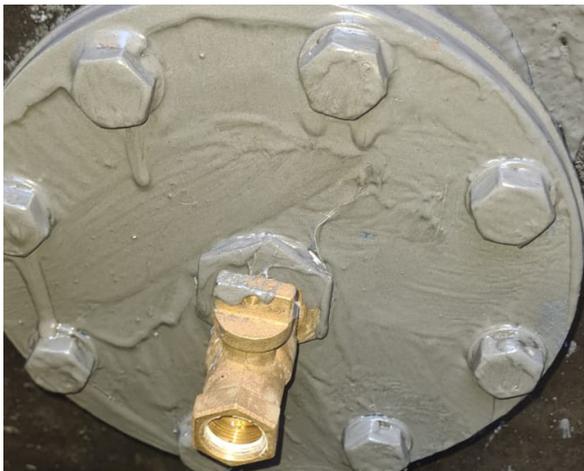
Liquid Metal shielded the flange plate from corrosion

An engineer from Arch Services accessed the chamber. The flange and stub were coated with several layers of **Liquid Metal Epoxy Coating** to create a new metallic surface which would act as an external shield against corrosion.

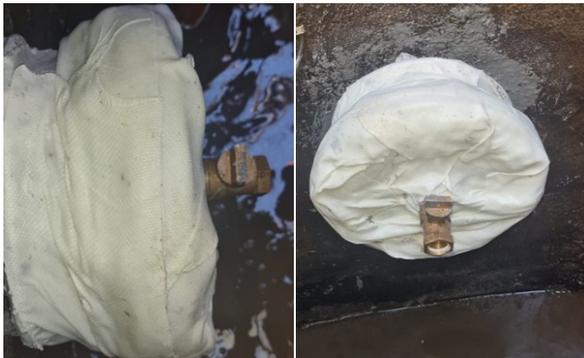
SylWrap HD was wrapped around the stub and smothered over the flange plate for protection

The stub was then encapsulated with **SylWrap HD Pipe Repair Bandage**. SylWrap HD was applied around the stub and smothered over the plate. Once cured, it provided a rock-hard, impact resistant protective covering for the pipe.

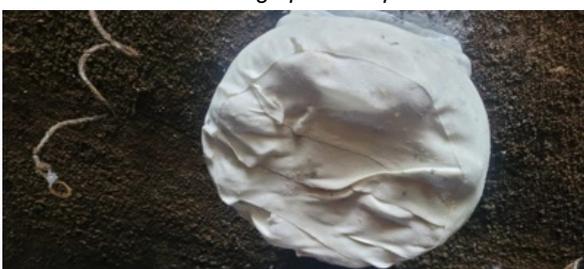
Completed repair with the entire stub encapsulated
