SYLWRAP Case Study

Cracked Wall Between River and Trout Farm Repair

The Environment Agency repair a crack in an underwater wall between a river and a trout farm which was causing issues with the monitoring of water levels

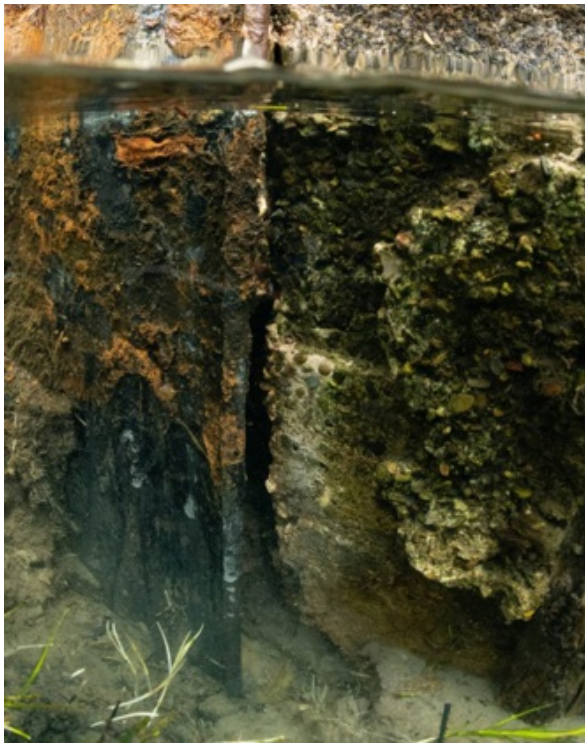
The crack ran for 700mm, starting above the waterline and progressing down to the riverbed

Anomalies with data from one farm alerted the EA to an issue. An inspection revealed a 700mm long crack in a wall next to a sluice.

The crack needed sealing to prevent water loss from river to farm, and ensure accurate recording of how much water was being drawn.

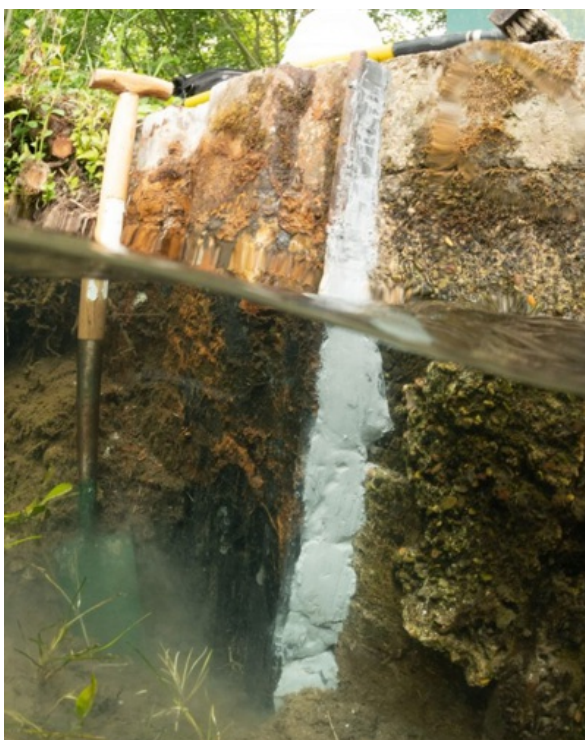
AB Original was pushed into the crack, sealing along its entire length above and below the waterline

With most of the crack below the waterline, the EA required a material capable of underwater repair. They used **Sylmasta AB Original Epoxy Putty**.

The putty was mixed in dry conditions. Whilst soft, it was pushed into the crack. The repair started above the waterline, working down to the riverbed.

Monitoring of water levels after the repair showed a small leak remained. This was identified as being at the crack's widest point near the riverbed. It was sealed with further AB on a second visit.
