SYLWRAP Case Study

Portable Horse Shower Burst Pipe Repair

Sylmasta and Showerking team up to provide a repair method for portable horse shower units with burst copper pipes caused by freezing temperatures

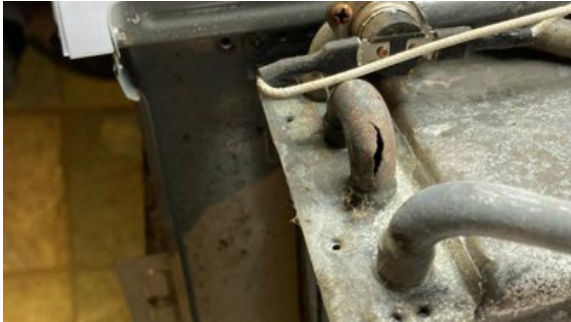
Freezing temperatures caused copper pipework in horse shower units which had not been fully drained to suffer from cracks and bursts

Showerking units are kept in unheated outbuildings. When not fully drained, copper pipe in the system can become prone to bursting during exceptionally cold weather.

When UK temperatures went as low as -15°C, several horse shower owners reported burst pipes, rendering their units unusable.

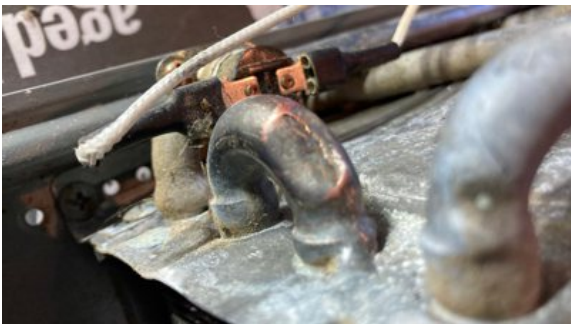
The pipe was cleaned of loose material before repair to aid adhesion with the Epoxy Putty.

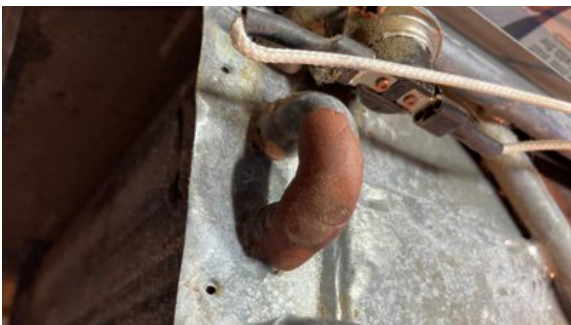
Superfast Copper Epoxy Putty was kneaded by hand and used to cover the crack

Loose material was first cleaned from the pipework. **Superfast Copper Epoxy Putty** was then kneaded by hand and applied, covering the crack.

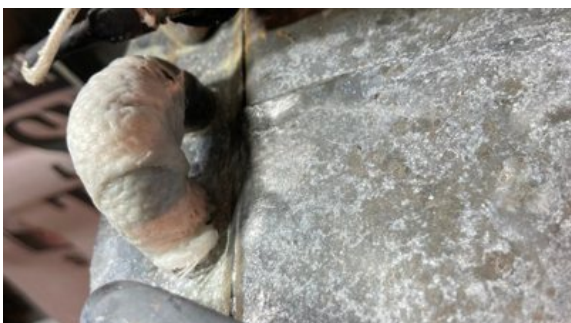
SylWrap HD Bandage forced the putty into the crack, creating a watertight seal and offering protection from future expansion of the pipe

Before the putty had fully hardened, a **SylWrap HD Pipe Repair Bandage** was wrapped over the entire leak area, forcing the putty into the crack for a permanent watertight seal.

Within five minutes, SylWrap cured to provide a rock hard shell which reinforced the repair and offered protection from future expansion.
