# SYLWRAP Case Study

## Ductile Pipe System Corrosion Protection

Corrosion protection measures are made to a 600mm ductile pipe system showing early signs of surface damage in an underground pumping station

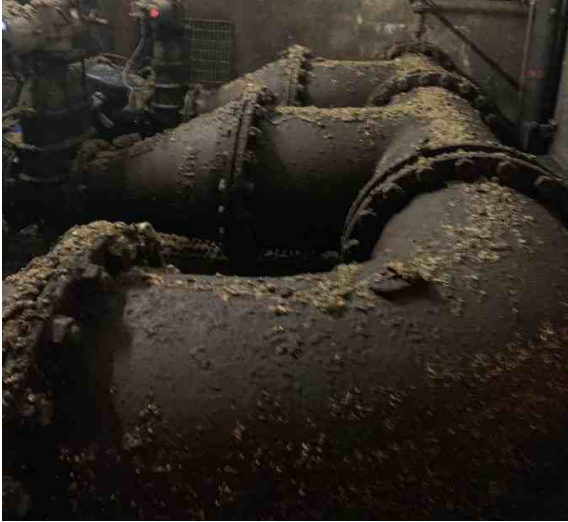
*The pipe system was covered in contaminants and showing early signs of external surface damage*

Conditions inside the chamber were ripe for corrosion. Rainwater, sand and other contaminants could settle on the pipe, causing early signs of surface damage.

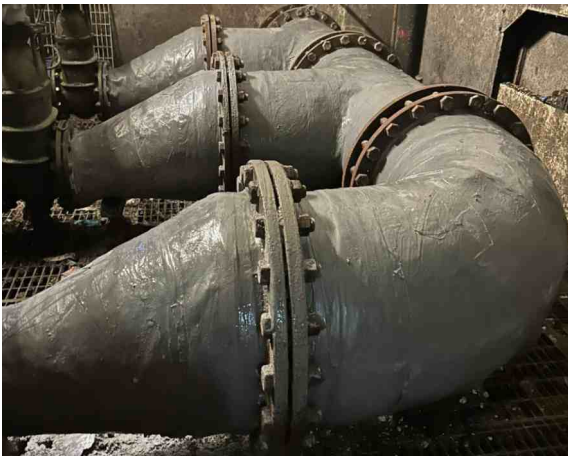
The main section of pipe ran for five metres. Three outlets branched off which were two metres long with reducing spools to 200mm diameter at the isolation valves. The system contained a total of six flanges.

The pipe was cleaned and the entire main section, three outlets, reducing spools and six flanges all coated with **Liquid Metal Epoxy Coating**.

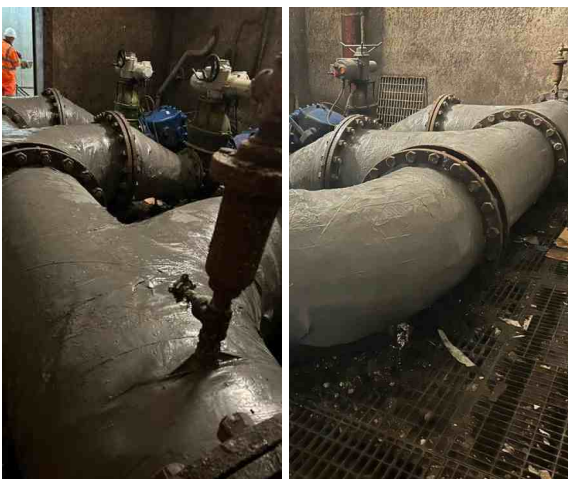
*Liquid Metal and SylWrap Bandage combined to form a robust outer shield protecting against corrosion*

Liquid Metal cured to form a smooth, metallic, hard-wearing outer surface to act as a shield against external corrosion. The protective layer was further enhanced with **SylWrap Pipe Repair Bandage**.

Four layers of SylWrap were applied, creating a rock-hard, impact resistant sleeve running as close to the flange plates as possible. A final coating of Liquid Metal was then painted over the SylWrap Bandage.
