SYLWRAP Case Study

CHP Plant High Temperature Pipe Repair

A pipe in an automotive company's on-site CHP Plant required a versatile repair with high temperature resistance to prevent a disruptive shutdown

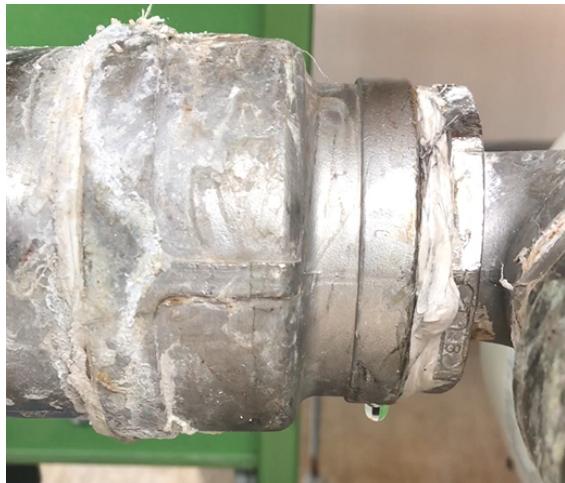
The leak area was situated on a very difficult section of the pipe, making the repair challenging

The leak was on an elbow joint on a pipe operating at temperatures up to 120°C as part of the system in a Combined Heat & Power (CHP) Plant.

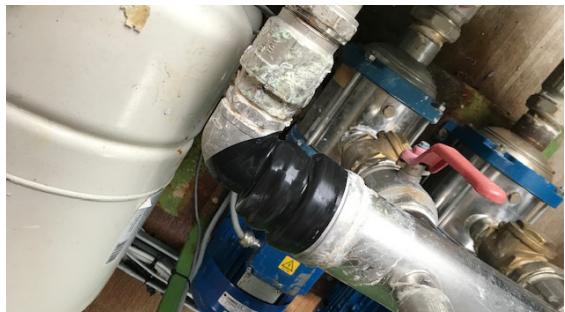
The high temperature resistance and versatility of Wrap & Seal made it ideal for sealing the leak

To seal the live leak, **Wrap & Seal Pipe Burst Tape** was wrapped around the elbow, encompassing the entire joint through its versatility. It fused to provide a high-pressure repair temperature resistant up to 200°C.

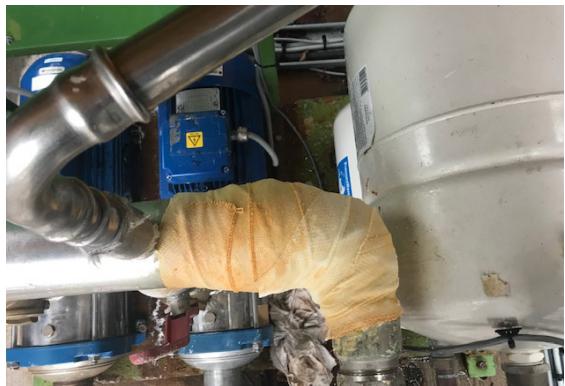
SylWrap HD provided an impact resistant layer over the initial repair. It tinged red because of the high temperature but could be painted to match the pipe at a later date if required

A **SylWrap HD Pipe Repair Bandage** was then applied over the Wrap & Seal as a protective layer, turning the repair permanent. The Bandage tinged red as a result of the pipe temperature. If the factory wished for it to be uniform to the pipe, then they could paint it at a later date.
