SYLWRAP Case Study

Swimming Pool Filtration System PVC Pipe Repair

A difficult live leak repair of a PVC plastic pipe in a leisure centre swimming pool filtration system prevents the need for the time-consuming and costly disassembly of half the system to fit a replacement section of pipe

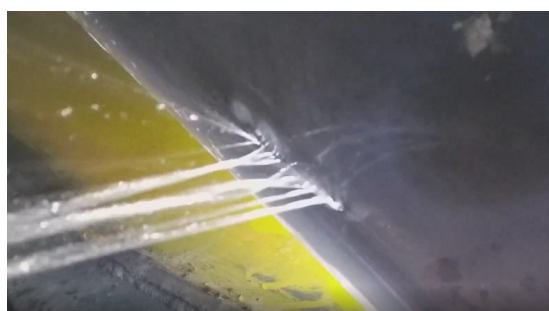
The 50mm crack in the pipe facing towards ground

After many years resting on a steel bracket, a 50mm crack developed in a PVC pipe, part of the filtration system in a leisure centre swimming pool.

The pipe was located just 76mm off the ground and surrounded by other components of the system, making a repair difficult. Replacing the section required the disassembly of half the system.

The crack was facing towards ground, meaning the only way to see the leak location when working from above was by keeping water pressure on.

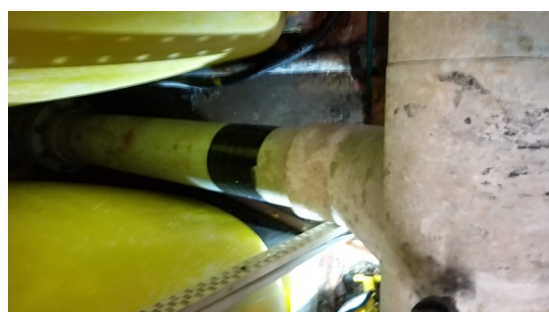
Wrap & Seal Pipe Burst Tape successfully sealed the leak despite the space constraints

Because a live leak repair was necessary, **Wrap & Seal Pipe Burst Tape** was used to seal the leak. The tape could not be stretched by its full 300% due to the space constraints, but it still fused successfully to provide a pressure resistant repair.

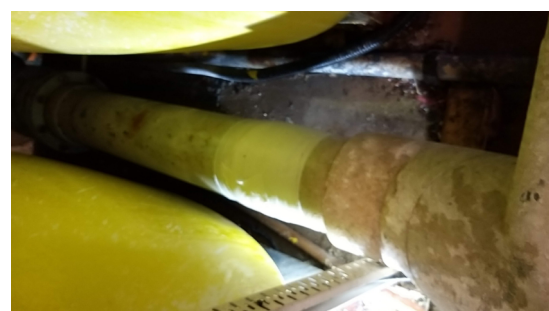
SylWrap HD Pipe Repair Bandage provided an impact resistant layer over the initial repair

A **SylWrap HD Pipe Repair Bandage** was then applied over the Tape for an impact resistant layer and to further protect the pipe from the bracket. The repair was completed in under one hour.

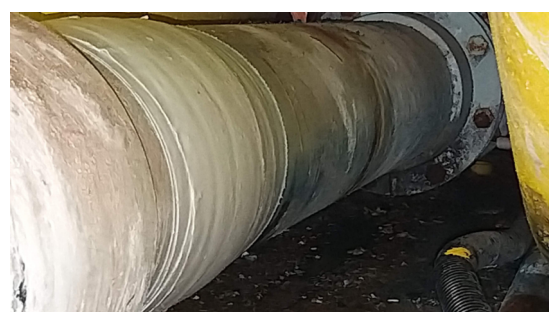
Further SylWrap was then applied to the pipe to strengthen and protect it from future wear and tear
