SYLWRAP Case Study

Underground Heating Pipe Repair

When contractors accidentally cut through an underground heating pipe with heavy insulation lagging which supplied a farmhouse, a rapid live leak repair was required to keep the hot water on

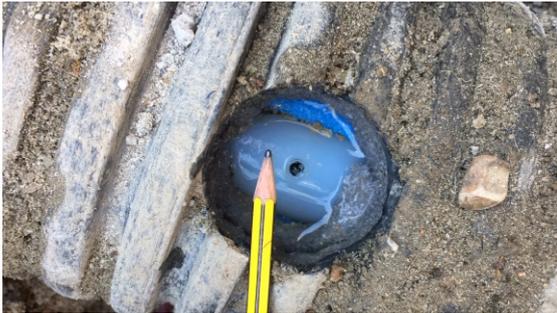
The pinhole caused when the pipe was cut into

The contractors cut into the pipe with a hole saw believing it was an unused drainage pipe. Once breached, they realised it was an outer pipe and an inner piper with a layer of insulation lagging.

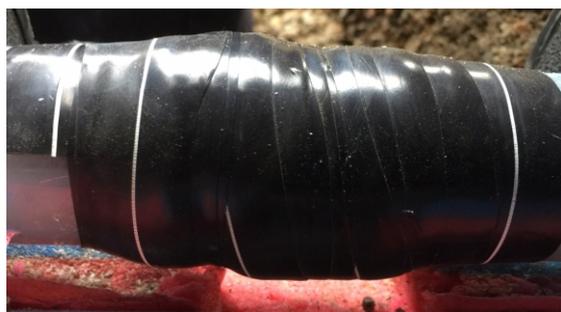
Wrap & Seal sealed the hole with a temperature resistant repair

Instead, minimal lagging was removed to reach the pinhole leak and **Wrap & Seal Pipe Burst Tape** applied around the heating pipe. The Tape self-fused into a solid rubber band, sealing the leak, with a temperature resistant repair up to 200°C.

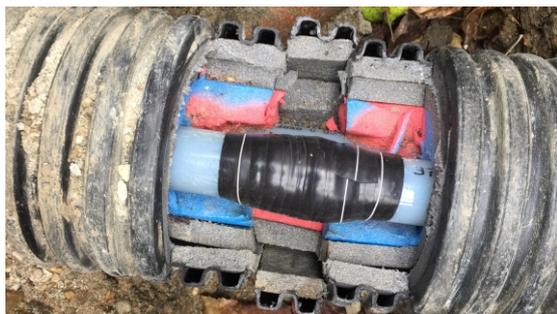
The heating pipe repaired with Wrap & Seal after the outer pipe and insulation lagging were cut away

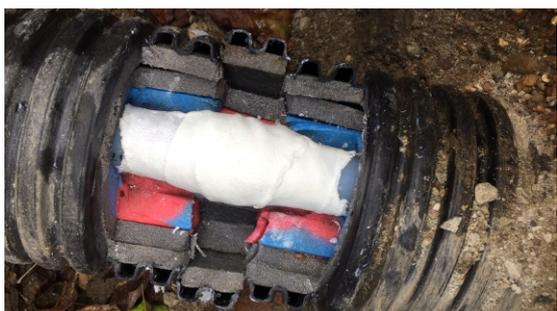
SylWrap HD added a further layer of protection to the pipe from the farm's building works

SylWrap HD Pipe Repair Bandage was then wrapped over the repair, providing a further layer of protection to the pipe from the continuing building works.
