# SYLWRAP Case Study

## Bahrain Airport Leaking Step Joint Repair

Bahrain International Airport required a live leak repair method for a step joint on a 100mm UPVC pipe so that a shutdown of systems could be avoided

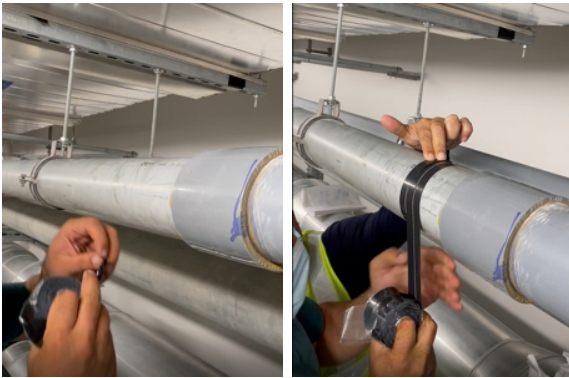
*The pipe was leaking from the left hand side of the joint with the application of Wrap & Seal starting 100mm away to build up a ridge towards the step*

Solvent cement bonds holding the pipe together had begun to weaken, allowing water to seep out through a step joint connecting two sections.

As this was a live leak, **Wrap & Seal Pipe Burst Tape** had to be used. To create a repair capable of sealing the step, wrapping began some 100mm away from the joint with a 50% overlay.

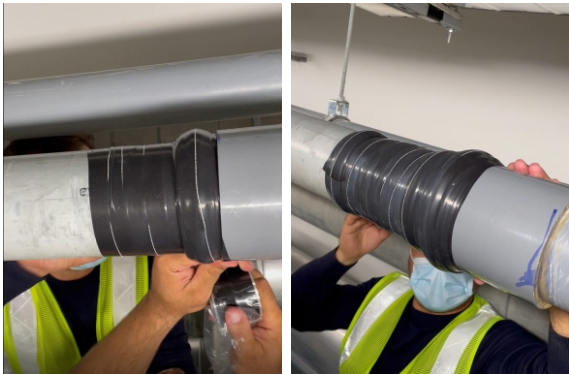
*Once the ridge reached level height with the step, wrapping continued to encompass the joint*

After reaching the step, layers of Tape were built up next to it, creating a ridge. Once the ridge was level height with the step, wrapping continued for 50mm across the step, encompassing the whole joint.

Two 50mm x 4m Tapes were required to completely seal the leak, self-fusing to each other to form a solid rubber band.

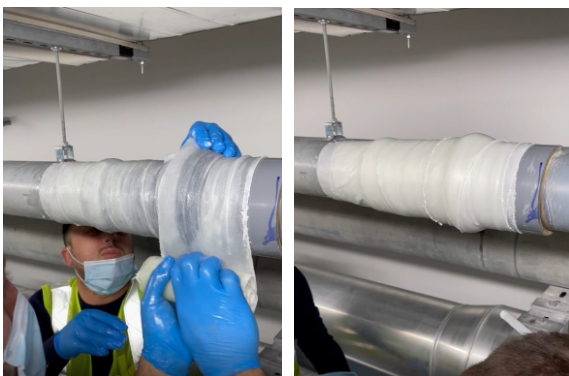
*SylWrap HD provided a rock hard, protective sleeve to complete the repair*

A **SylWrap HD Pipe Repair Bandage** was then wrapped over the entire repair, providing an impact resistant, protective shell.
