Ceramic Brushable Case Study

Corroded Blades in a Flour Mixer Repair

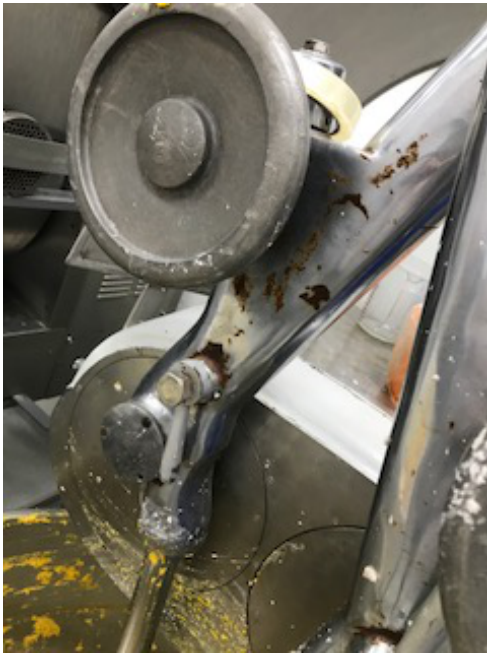
An example of the sort of corrosion which the flour mixer was suffering from prior to repair

The corrosion was discovered during a regular inspection of the flour mixers, which had to be shutdown immediately as a result.

Sylmasta recommended the use of **Ceramic Brushable Green** for the repair. Several coatings of the liquid epoxy were brush applied to refurbish the metal blades; offer greater corrosion protection; and reduce the damage caused by future abrasion thanks to the epoxy's low friction finish.

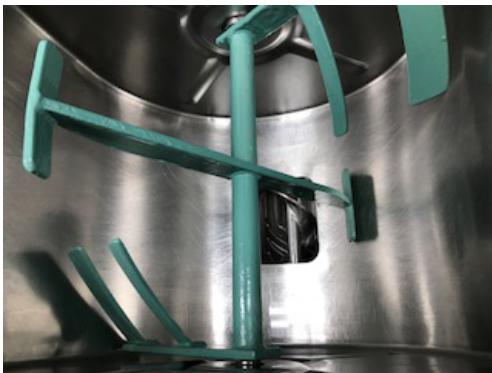
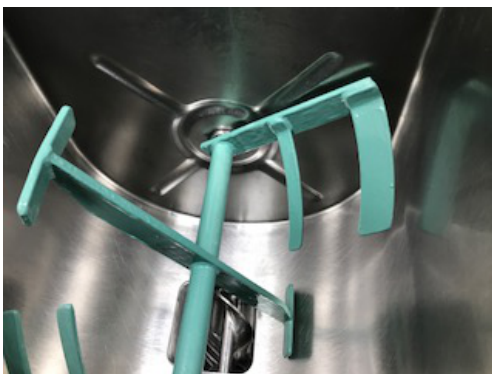
The corroded blades inside the mixers after the application of Ceramic Brushable Green

Within 24 hours of the final coating, both flour mixers were put back into operation to return the bakery to full capacity.
