# SYLWRAP Case Study

## Camper Van Boiler System Pipe Repair

A difficult-to-access cracked copper pipe in a camper van boiler system losing water whenever the system was turned on is repaired by the van's owner

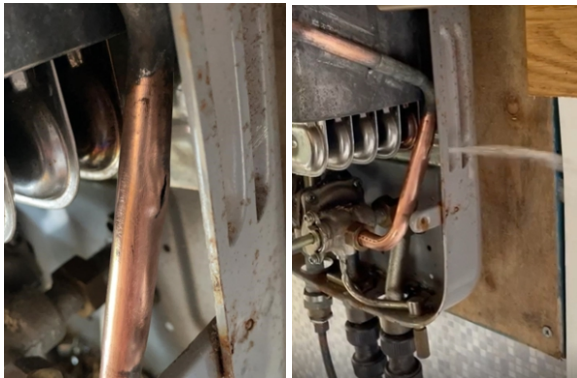
*Crack in the pipe was difficult to access. When the boiler system was turned on, a pressurised jet of water sprayed out.*

Whenever the boiler system - which provided heat and hot water for the van - was turned on, a pressurised jet of water sprayed from the crack.

The hole was located in a section of pipe under the boiler cover and facing towards the side of the casing, meaning access was very restricted

This confined space meant there was no room to fit a clamp or for a self-almagamating silicone repair tape to be stretched enough for effective fusion.

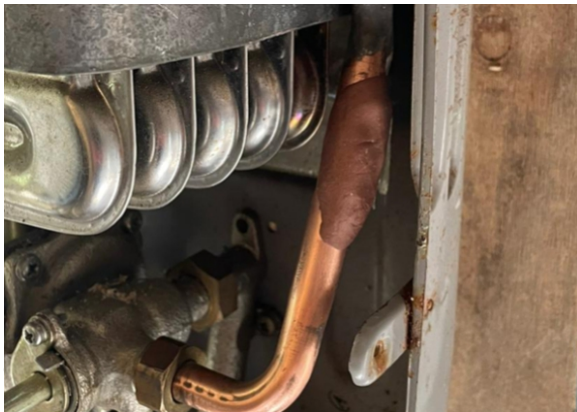
*Superfast Copper plugged the hole in the pipe*

As the boiler could be turned off, Superfast Copper Epoxy Putty Stick was used to plug the hole. The pipe was cleaned and dried prior to application to aid the adhesion of putty to metalwork.

The putty was kneaded by hand and applied to a section of pipe both above and below the area of damage. It hardened in 5 minutes, filling the crack.

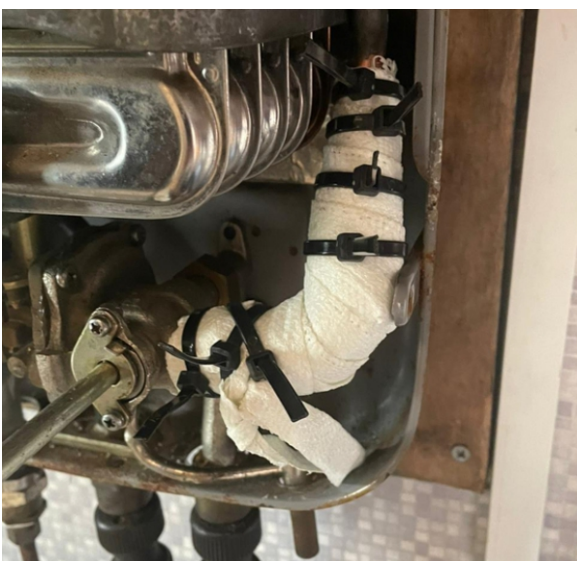
*Space constraints meant SylWrap HD was cable tied in place whilst it cured to reinforce the pipe*

A SylWrap HD Pipe Repair Bandage was then applied to cover the entire pipe. Because of the space constraints, wrapping in the normal manner was not possible and so the camper van owner cable tied the Bandage to the pipe whilst it cured.

Once the repair was completed, the boiler was turned back on. Water was no longer escaping from the pipe, denoting a successful repair.
