# SYLWRAP Case Study

## Repair & Reconnection of an Iron Water Supply Pipe

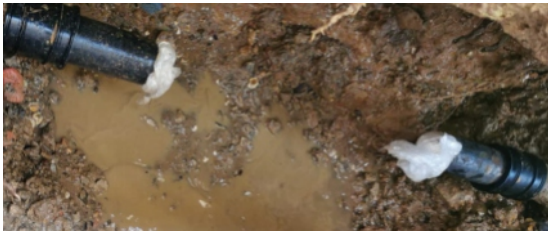
Supply line after the damaged section was cut away

Rupture in the pipe caused by several holes

Corrosion had caused the 100-year-old 70mm pipe to rupture. The contractor initially removed the damaged section with the intention of replacing it, only to discover fittings of the size and type needed were no longer manufactured due to the pipe's age.

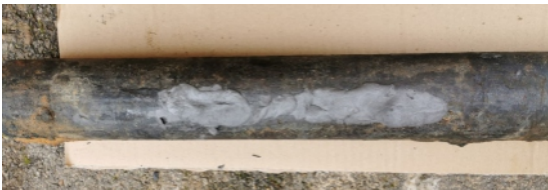
Holes in the pipe sealed with Superfast Steel

**Superfast Steel Epoxy Putty** sealed the rupture. The putty was overwrapped with **Wrap & Seal Pipe Burst Tape** to increase pressure resistance. A **SylWrap HD Pipe Repair Bandage** provided a protective shell over the initial repair.

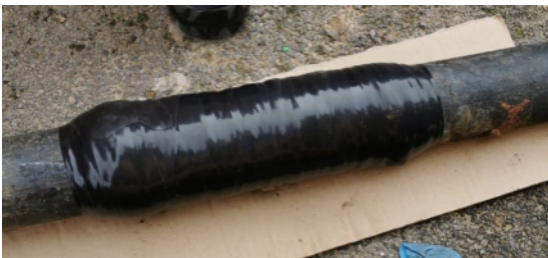
Wrap & Seal increased the pressure resistance

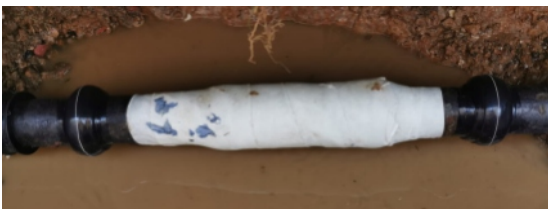
SylWrap HD covered the repair and Wrap & Seal reconnected the cut-out section to the pipe

To reconnect the cut-out section to the supply line, **Wrap & Seal** was applied at the joints. The full length of pipe was encompassed with further **SylWrap HD** to reinforce the connections and protect the entire repair. This final layer was painted black to make it uniform with the pipe.

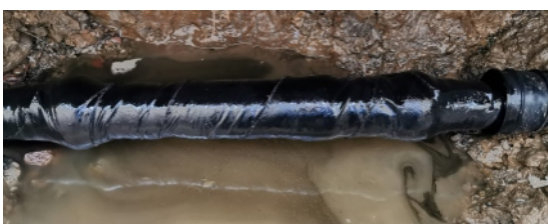
Second SylWrap HD Bandage encompassed entire pipe, painted black to appear uniform
