Industrial Metal Case Study

Drill Stand Base Repair & Refurbishment

An engineer refurbishes a second-hand drill base stand with a deep gouge using Industrial Metal Epoxy Paste at a fraction of the cost of buying new

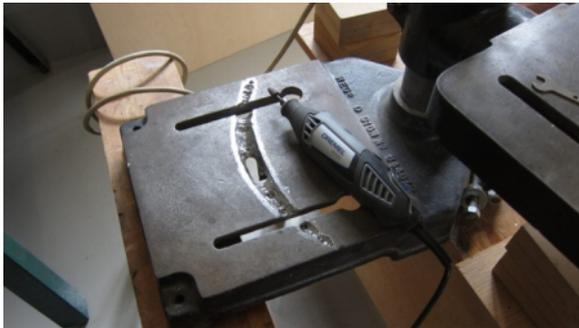
Deep gouge in the drill base stand caused by misuse

The deep gouge had been caused by the previous owner allowing the drill to penetrate the base. Due to the damage, they had decided to sell the stand.

Sylmasta recommended the use of **Industrial Metal Epoxy Paste** for filling in the gouge.

Industrial Metal was then pushed into the gouge using a hand tool, rebuilding the base by curing to form a new metal surface within an hour.

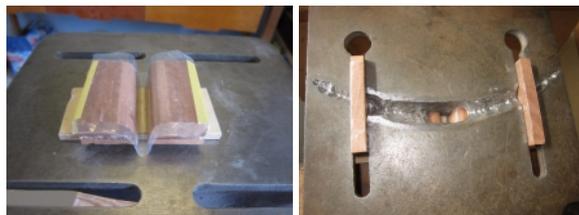
Wood used to prevent epoxy paste from passing through the gouge or curing in gaps in the base

The gouge had penetrated right through the base. A wooden plate was placed underneath to prevent the epoxy paste falling to the floor as it was applied.

Further wood was used to ensure the necessary gaps in the base were not filled with paste. All traces of rust and grime were removed from the base and it was roughened up with abrasives.

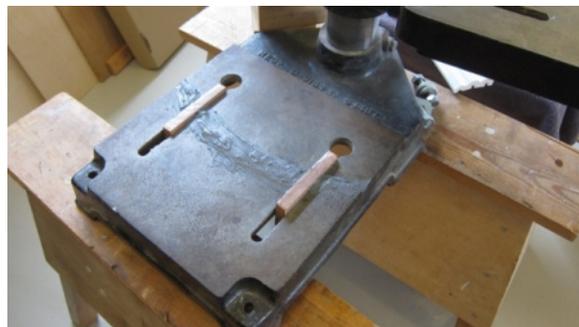
Industrial Metal was applied with a hand tool to rebuild the damaged area of the stand

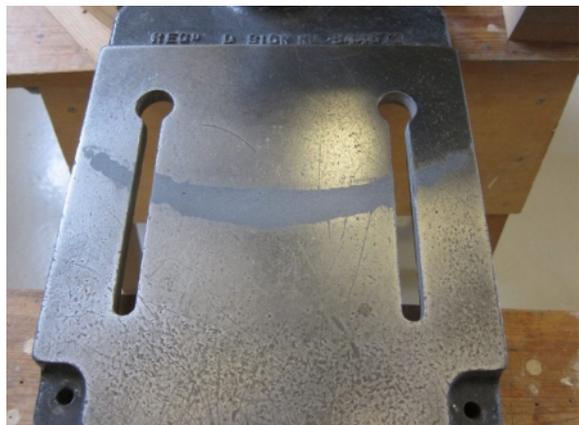
Once cured, the epoxy paste was sanded down to leave an ultra-smooth finish

A full cure was achieved in 24 hours, after which the surface was sanded down. This left an ultra-smooth finish seamless with the rest of the base.
