SYLWRAP Case Study

80mm Longitudinal Split in a Plastic Hose

A 300mm area of plastic hose supplying water to a pond became damaged during landscaping work, including an 80mm split requiring leak repair

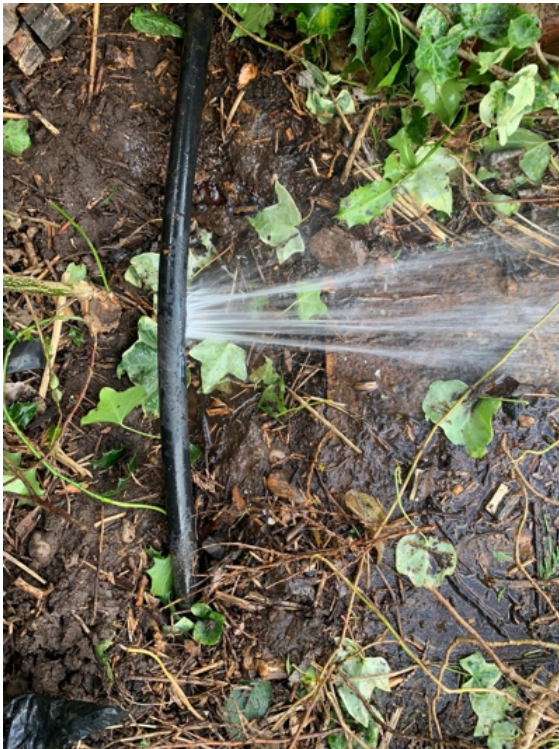
A 80mm longitudinal split was surrounded by smaller leaks, leaving a damage area of 300mm. A flexible repair method was required, capable of working around the roots, the wall and the ground.

Water escaping from 80mm split in the hose

Water supply was turned off and the hose cleaned to remove all traces of soil. A plastic sheet was placed under the hose to prevent soil or grit being picked up during the repair.

Wrap & Seal Pipe Burst Tape was wrapped around the entire section of damage. Despite the space constraints, it could still be stretched by 300% to seal all leak areas.

The repair was completed with a **SylWrap HD Pipe Repair Bandage** providing an impact-resistant protective layer before the hose was reburied.

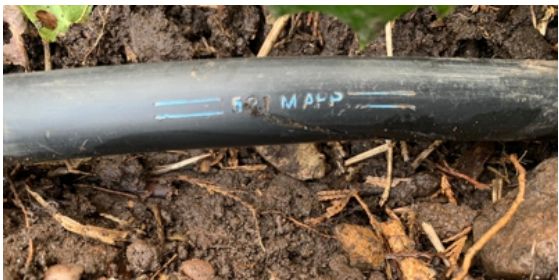
The hose was buried into the side of a hill with a retaining wall behind. Roots were starting to cause structural damage to the wall, so the property owner decided to cut them away with a pruning saw, inadvertently damaging the unnoticed hose.

The hose had been badly cut by a pruning saw

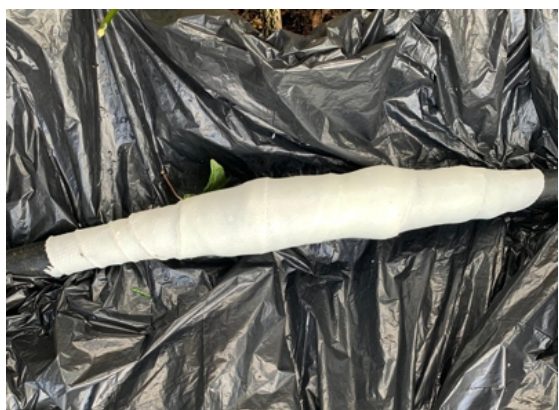
Completed repair with SylWrap HD applied to cover the entire damage area
