# SYLWRAP Case Study

## Cast Iron Wastewater Pipe Repair

A central London hotel faced having to close one of its most popular rooms after a cast iron wastewater pipe developed a large hole on an elbow joint

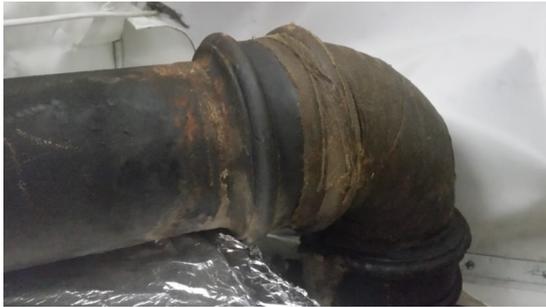
*First failed repair made using a pipe repair wrap*

A previous repair attempt had seen the hotel apply a repair wrap but because of the size of the hole, the pipe began leaking as soon as water pressure was turned back on.

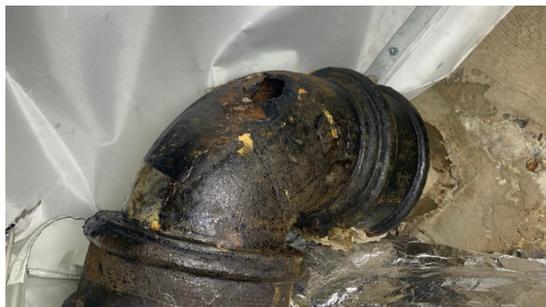
*The 50 x 25mm hole in the pipe was located on a difficult elbow joint*

A 50 x 25mm hole on an elbow joint had developed in the pipe, which was located between the floor of one level of the hotel and the ceiling of another. Access was difficult with little room around the pipe.

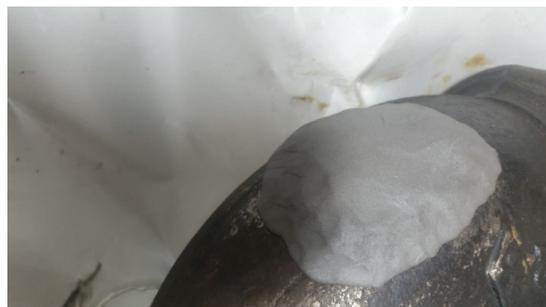
*Superfast Steel Epoxy Putty formed into a circular disc and used to seal the hole*

**Superfast Steel Epoxy Putty** was formed into a circular disc larger than the hole and attached to polythene sheeting. The disc of putty was then positioned over the hole with the edges pushed firmly onto the cast iron surface to form a good bond with the pipe, covering the hole.

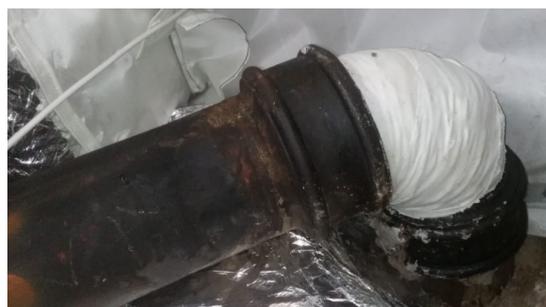
*The repair was completed by overwrapping with a SylWrap HD Pipe Repair Bandage*

Once cured, the putty successfully sealed the hole. It was overwrapped with a **SylWrap HD Pipe Repair Bandage** which provided an impact resistant layer over the initial repair for a permanent solution.
