SUPERFAST Case Study

Magic Corner Kitchen Unit Repair

The high-strength bonding properties of Superfast Steel enable the repair of a collapsed magic corner kitchen unit which would have cost £290 to replace

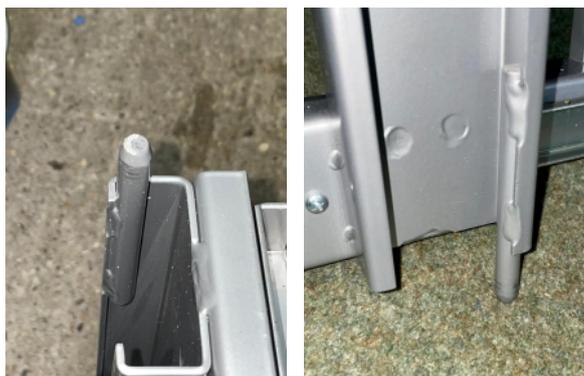
How the pin would have looked when welded to the magic corner unit prior to snapping off

An inspection revealed that a vital 100mm pin upon which the magic corner pivoted had broken away from the frame where it had been welded in place.

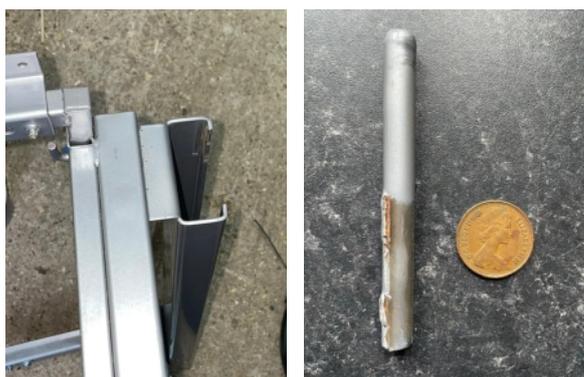
Part of the unit from where the 100mm pin snapped off and the pin itself once detached from the unit

A combination of the age of the unit, wear and tear and overloading had caused the magic corner to collapse, detaching it from the kitchen cupboard door where it had been fitted.

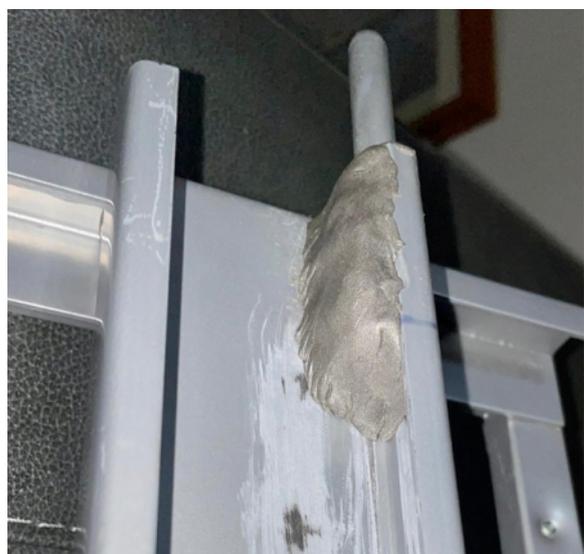
Pin permanently reattached to the unit, avoiding the £290 cost of buying a replacement magic corner

The pin needed to be reattached to the magic corner using a bonding method strong enough to be comparable to the original welding.

Superfast Steel Epoxy Putty Stick offers super-strength adhesion between materials. Putty was cut from the stick and kneaded by hand.

Whilst soft, it was moulded against the frame to hold the pin back in place. The putty cured in around 10 minutes, forming a material as hard of steel to permanently fix the pin in position.

Within an hour of the application, a full cure had been achieved and the magic corner could be filled with items again.
