# SYLWRAP Case Study

## Pumping House 150mm Elbow Live Leak Repair

A water company in Malaysia make a live leak repair to a 150mm steel elbow under 6 bar pressure in a pumping station after a pinhole leak developed

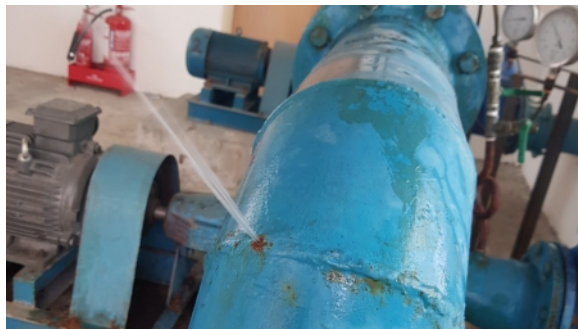
*A jet of water was escaping the elbow at 6 bar from a pinhole leak caused by corrosion*

Corrosion had weakened the elbow where two sections of metalwork met, creating a pinhole. Water was jetting out of the leak at 6 bar pressure.

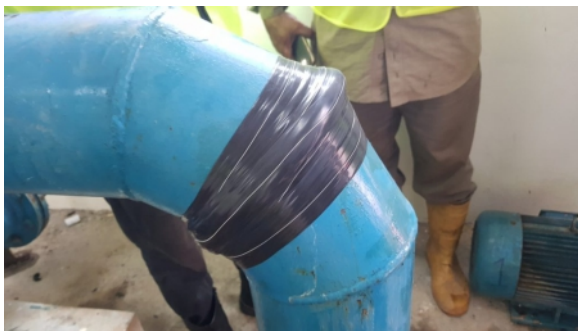
*Wrap & Seal was stretched by 300 percent, fusing to form a solid silicone band over the pinhole*

**Wrap & Seal Pipe Burst Tape** was applied to seal the leak. The Tape was stretched by the maximum 300 percent and fused to form a solid silicone band over the pinhole, withstanding the 6 bar pressure.

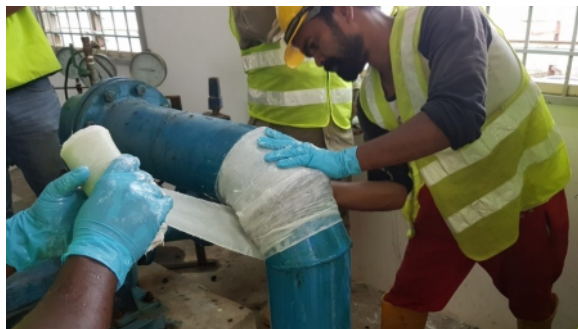
*SylWrap HD reinforced the initial repair, smoothed around the pipe to create a protective sleeve*

The repair was then reinforced with a **SylWrap HD Pipe Repair Bandage**. The Bandage was wrapped and smoothed around the pipe whilst water was poured over it, curing to provide an impact resistant protective sleeve around the elbow.

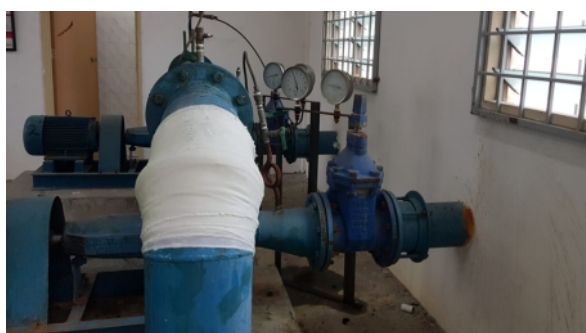
*The repair of the elbow was completed in under 30 minutes with no disruption to the pumping station*

Completing the repair took less than 30 minutes with no interruptions to the pumping house.
