# Ceramic Brushable Case Study

## Improving Efficiency of Extruder Barrels

Ceramic Brushable Blue provides an abrasion resistant, ultra-smooth surface to improve the efficiency of barrels in several pug mill putty extruders

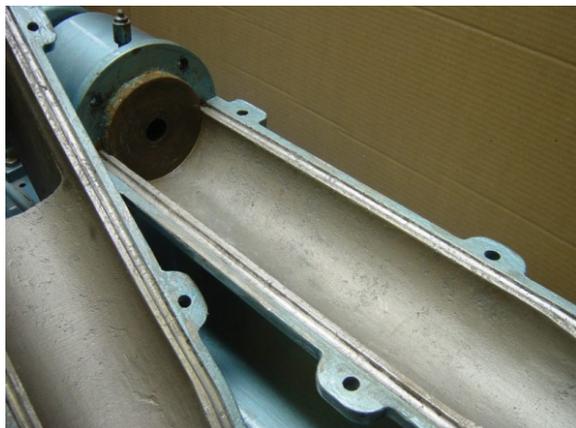
*Aluminium barrels in the putty extruders suffering from wear which was impacting on efficiency*

Over time, silica-filled putty extruded from the pug mills had caused abrasive wear to the surface of the aluminium barrels as it passed through.

This wear combined with the rough cast finish of the aluminium had caused the flow rate of putty from the pug mills to slow, impacting on efficiency.

To help the extruders run more efficiently, it was decided to smooth the barrels off and make them more resistant to future abrasion.

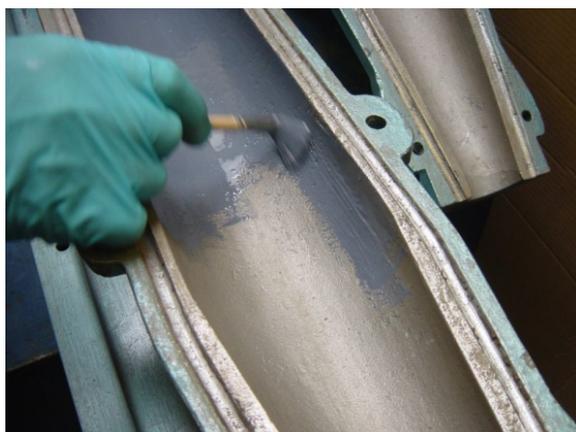
*Ceramic Brushable Blue was easy to apply to the barrels using a traditional paintbrush*

It was instead decided to paint the barrels with **Ceramic Brushable Blue**, a ceramic-filled epoxy coating reinforced with silicone carbide for ultimate hardness.

The coating was easy to apply using a traditional paintbrush and a work time of 90 minutes allowed large quantities to be mixed without the threat of premature curing.

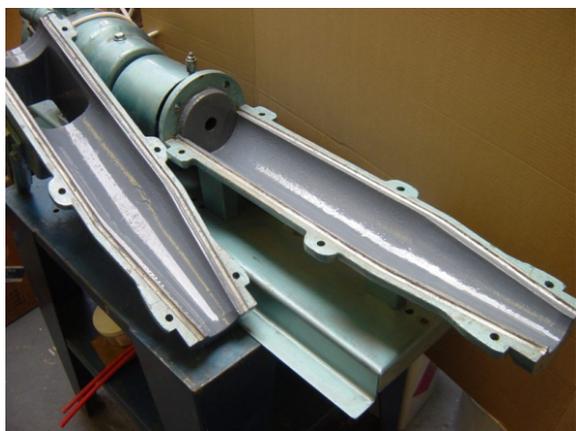
*Completed repair. Every extruder barrel was provided with an abrasion-resistant, smooth finish*

Ceramic Brushable provided a toughened, reinforced layer of protection against abrasion and an ultra-smooth, non-stick finish. This enabled quicker and easy cleaning of the barrels, offering further improvement in efficiency for the pug mills.

Every pug mill extruder was coated in one day. Full cure was achieved in 24 hours, resulting in minimal disruption to production.
