# SYLWRAP Case Study

## Contaminated Wastewater Pipe Live Leak Repair

When contractors carrying out upgrades at a Wastewater Treatment Works cut through a pressurised 450mm steel contaminated water pipe, a rapid live leak repair was required to prevent an environmental catastrophe

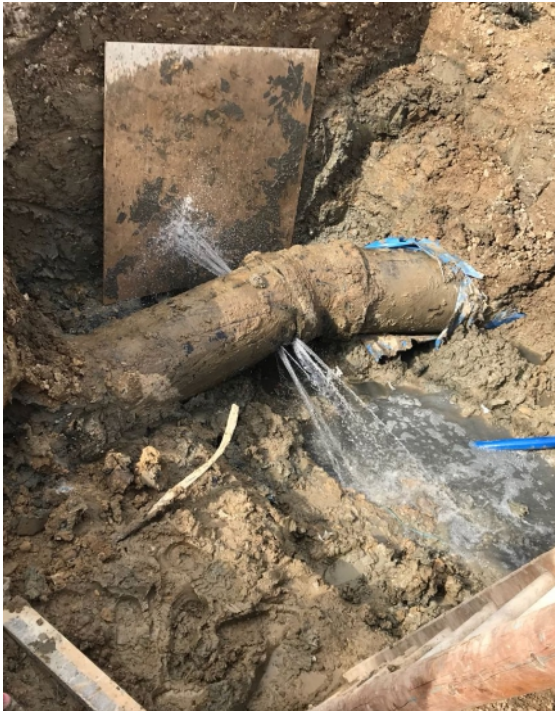
*Significant amounts of contaminated water were escaping from the damaged pipe*

The contractors mistakenly cut into the pipe believing it to be decommissioned for removal. Once it was breached, they realised it was connected to all the waste treatment ponds.

The severity of the cuts resulted in large amounts of contaminated water escaping. Isolating the pipe would have involved the shutdown of the entire site. There was no feasible way to stop the flow other than a live leak repair.

The site was less than one hour from Sylmasta HQ. Sylmasta delivered **Wrap & Seal Pipe Burst Tape** and **SylWrap HD Pipe Repair Bandage** and stayed on site to provide technical assistance.

Multiple tapes sealed the high pressure leak, fusing into a solid rubber band over the breached pipe. The tape was overwrapped with the bandage, providing an impact resistant layer of protection.

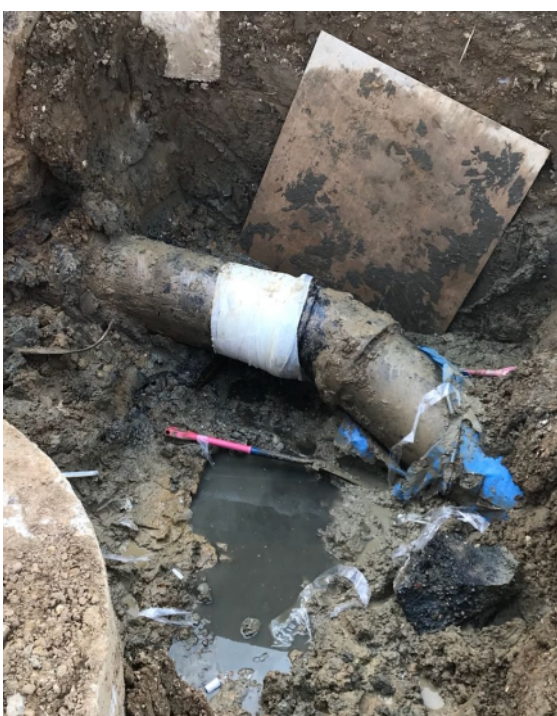
The repair was completed in one hour and for just £300. It prevented the shutdown of the facility, and stopped a serious environmental incident which could have left the treatment works with huge fines and a costly clean up.

*The repair prevented an environmental incident*
