# Ceramic Supergrade Case Study

## Corroded Turbine Cooler Condenser Unit Rebuild

The iron face of a turbine cooler condenser unit deformed by corrosion at a power station is rebuilt to avoid the expensive installation of new parts

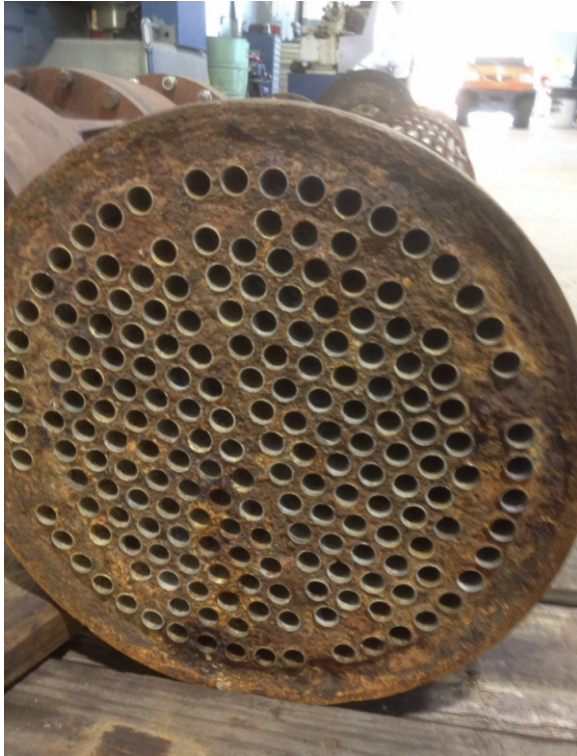
*The cast iron face of the condenser unit suffering from heavy corrosion after 20 years of service*

After such long service, the cast iron face was heavily corroded and deformed. Parts for this type of condenser were no longer made, so replacing the face would have involved specially fabricating new fittings and shipping them to Puerto Rico.

Sylmasta recommended the use of **Ceramic Supergrade Epoxy Paste** to rebuild and refurbish the face, and protect it from further damage.

The condenser was cleaned and rods were inserted into every tube hole in the face, covering them so they did not become inadvertently filled with epoxy paste during the application.

Ceramic Supergrade was then applied via a hand tool, filling imperfections in the cast iron and creating a new ultra-smooth, waterproof face with high corrosion and abrasion resistance.

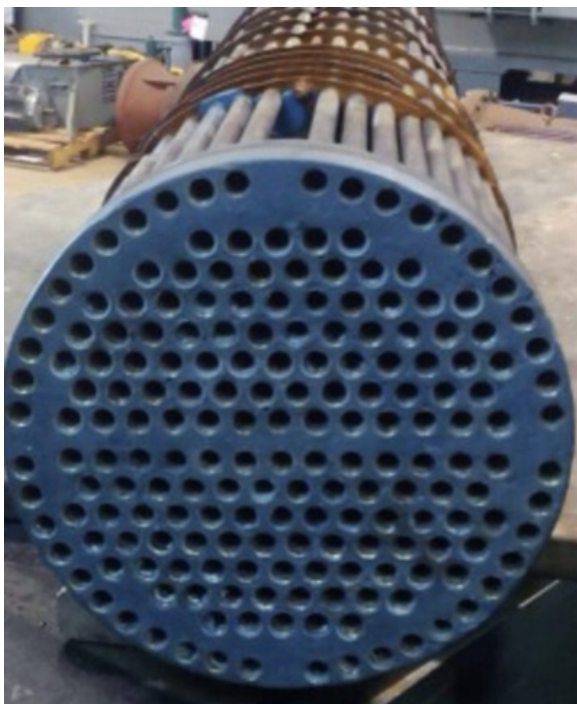
*Ceramic Supergrade rebuilt the face, creating an ultra-smooth surface with high corrosion resistance*

Within 24 hours, the epoxy paste had cured and the system was put back in operation.

The high-wear resistance of Ceramic Supergrade will keep the condenser in service until such time as the turbine is replaced.
