SYLWRAP Case Study

90-Year-Old Malleable Iron Water Pipe Repair

With replacement fittings no longer made for a 90-year-old water supply pipe, a homeowner needed a repair method to avoid digging out and replacing the line

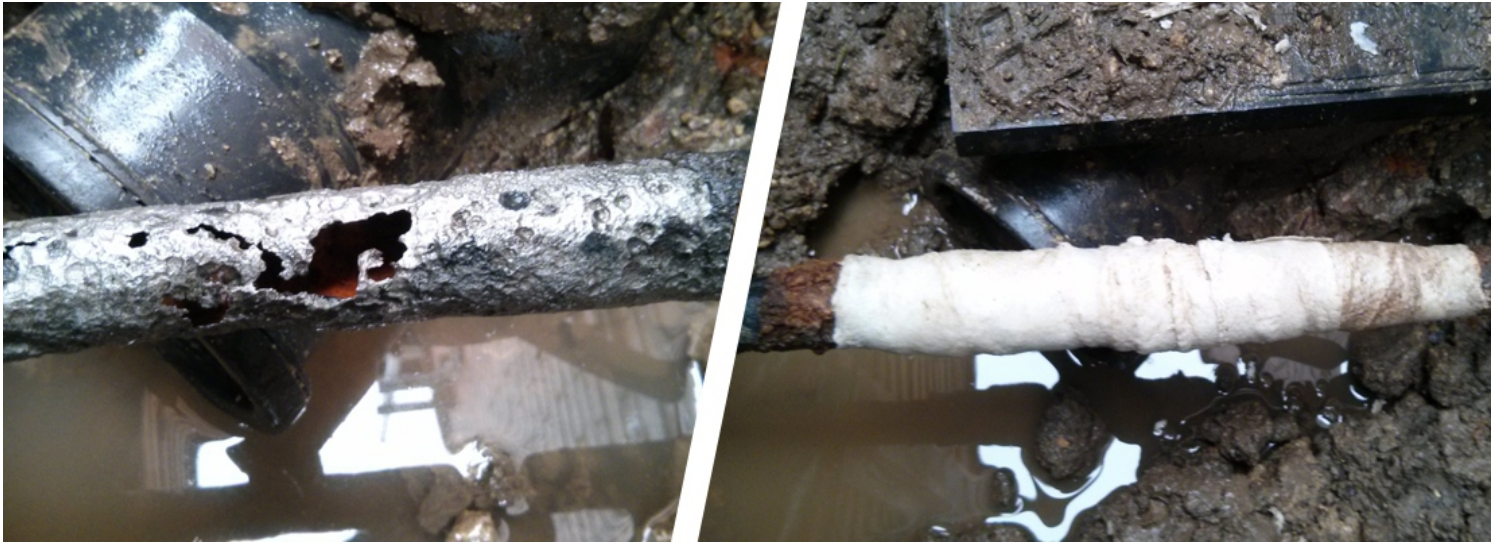
The 70mm malleable iron pipe connected the domestic property to the public water supply. After it was identified as leaking, excavation of the pipe revealed an awkward, number-9 shaped crack alongside several smaller holes.

Pressure could be isolated, so a **SylWrap Standard Pipe Repair Kit** was used. For the smaller holes, little chunks of **Superfast Steel Epoxy Putty** were kneaded by hand and applied to seal all leaks.

A large disc of Superfast Steel was formed to completely cover the number-9 shaped crack. This epoxy putty disc was stretched over the entire crack and the edges pushed down, forming a good seal with the surface of the pipe.

Once the putty had become firmer but not fully cured, **SylWrap HD Pipe Repair Bandage** was wrapped over the repair area. It compressed the putty into any remaining gaps before curing to form an impact resistant protective sleeve around the pipe.
