SYLWRAP Case Study

Suspended District Heating Pipe Repair

A 50mm steel pipe in a district heating system suspended in a ceiling required a live leak repair to keep the heating on after water began escaping

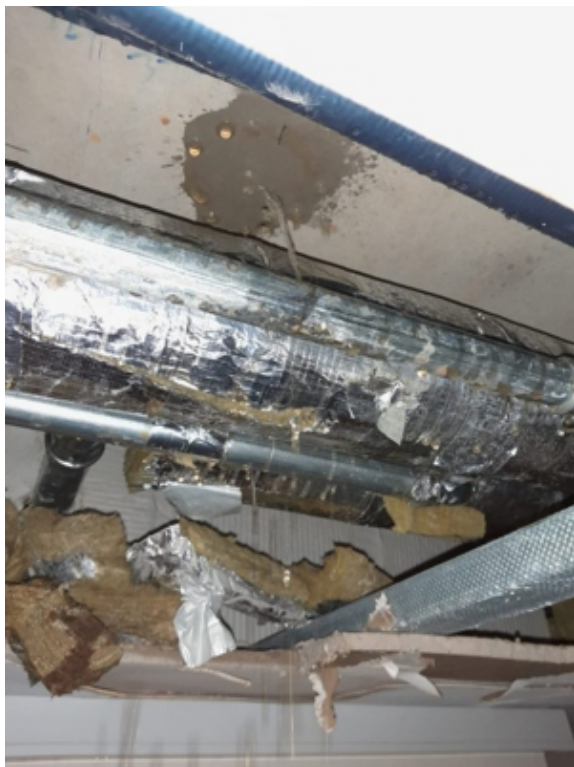
Steel pipe can be seen across the middle of the photo, spraying water which was damaging surfaces

A pinhole leak developed in a section of pipe suspended in the ceiling of a building. Pressurised water was jetting out in several directions, causing substantial damage to surrounding surfaces.

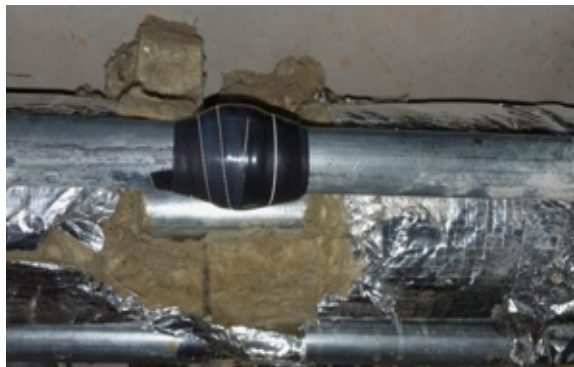
Wrap & Seal applied to seal all leak areas

A contractor was rushed to site. **Wrap & Seal Pipe Burst Tape** was applied to seal the leak. The Tape is temperature resistant to 260°C. It was stretched by the maximum 300% despite the lack of space, amalgamating to form a solid rubber band.

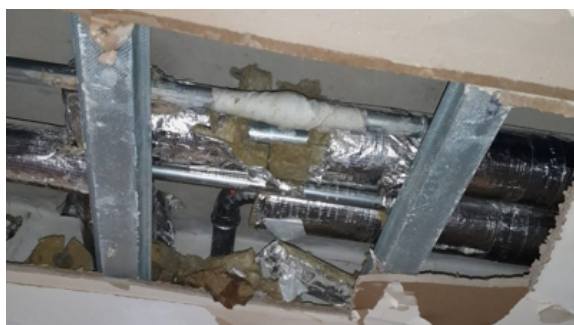
SylWrap HD encapsulated the pipe to finish the repair

The entire section was then encapsulated with a **SylWrap HD Pipe Repair Bandage**, which set rock hard in minutes to reinforce the repair and protect the pipe from future breakages.
