# SYLWRAP Case Study

## Bathroom Sink PVC Plastic Drain Pipe Repair

Cracks in a PVC plastic pipe located in cupboard underneath a bathroom sink undergo a quick, easy and inexpensive DIY repair by the homeowner

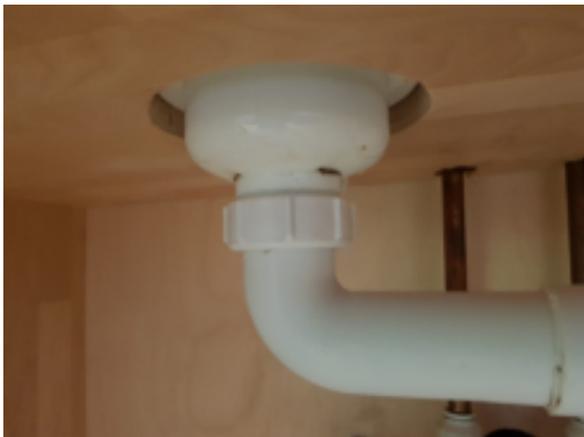
*Cracks had appeared in the top of the PVC plastic drain pipe where it connected to the sink*

The homeowner realised there was a problem when they noticed the bathroom floor next to the cupboard was wet.

After inspecting inside the cupboard, several cracks were noticed in the plastic drain pipe at the point it connected with the sink.

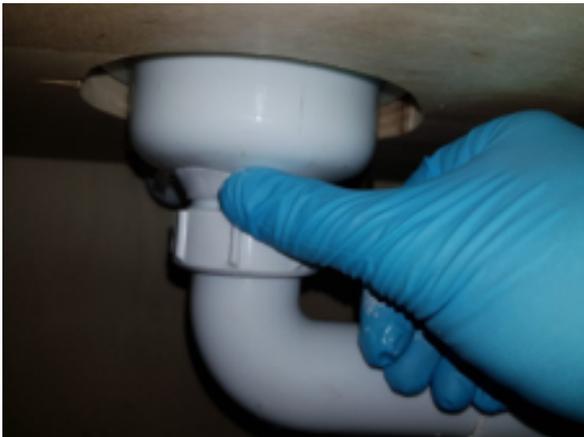
*Superfast Plastic was kneaded by hand, formed into a sausage shape and pushed over the cracks in the pipe whilst the putty remained soft*

A **Superfast Plastic Epoxy Putty Stick** was used to make a quick, easy and permanent repair. The pipe was dried and cleaned before the application.

The required amount of putty was then cut from the stick and kneaded by hand, turning from blue to white to indicate successful mixing.

Whilst soft, the putty was formed into a sausage-like shape and pushed against the pipe, covering all the holes.

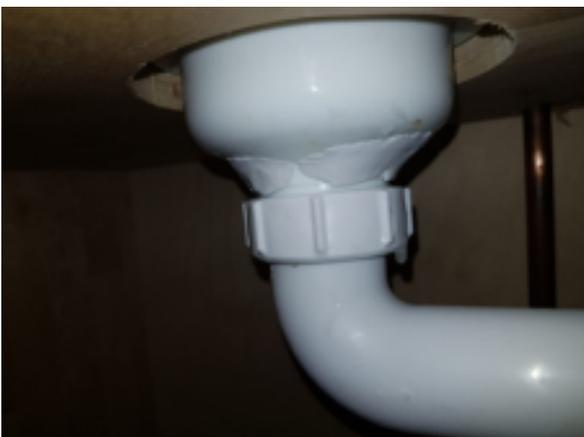
*The putty hardened, permanently sealing the cracks in the pipe and preventing any more water from escaping when the sink drained*

After 25 minutes it began to harden. Within 45 minutes, the putty had cured to provide a watertight seal, filling all holes in the pipe.

Superfast Plastic achieved full properties after two hours, at which point the homeowner ran the tap on their sink.

No water escaped as it drained, indicating a successful repair at a total cost including delivery of under £20.
