# Epoxy Putty Case Study

## Epoxy Putty Brick Repair & Restoration

Holes, cracks and chunks of missing brickwork caused by lime bow are seamlessly filled in and repaired using epoxy putty at a UK housing estate

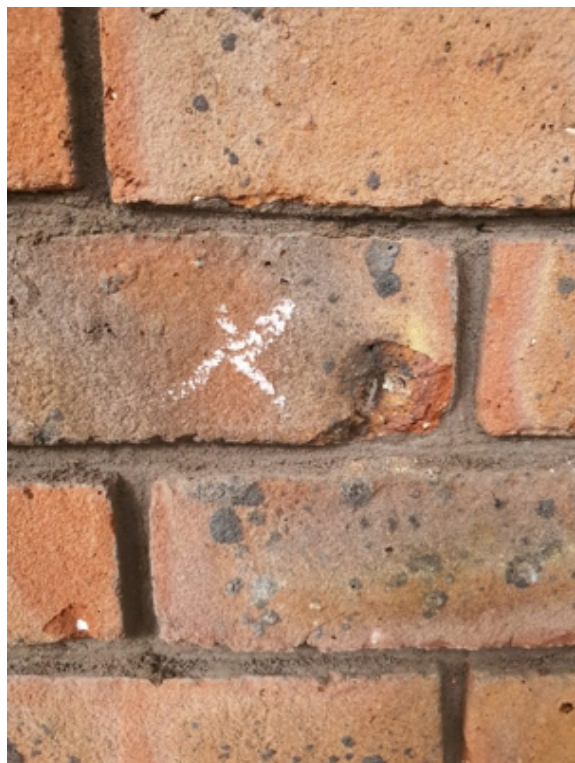
*Damaged caused by lime blow can be seen next to the 'X' marked in the brickwork*

When calcium oxide mixes with water, it begins to slake in a highly vigorous process known as lime blow. This can lead to the face of the brick erupting.

Brickwork at a new housing estate in the UK was suffering from severe lime blow caused by rainwater. A building firm were asked to find a cost effective method for filling the damage to repair the brickwork.

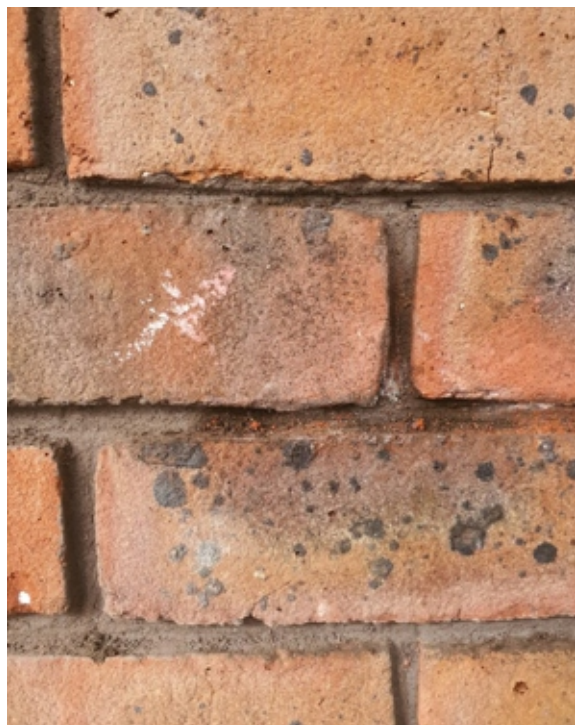
*AB Original mixed with brick dust and then spittled with a wire brush created a seamless repair*

AB Original was mixed by hand and pressed into the brickwork, where it filled all the damage. Once applied and whilst still soft, the putty was wetted with water so that brick dust could be easily adhered to colour it.

Dust was collected from the brick and pushed into the putty. This created a material seamlessly matching the wall colour.

To give the putty an identical texture to the brick, it was then spittled with a wire brush.
