Sylmasta AB Case Study

Epoxy Putty Brick Repair & Restoration

Holes, cracks and chunks of missing brickwork caused by lime blow are seamlessly filled in and repaired using epoxy putty at a UK housing estate

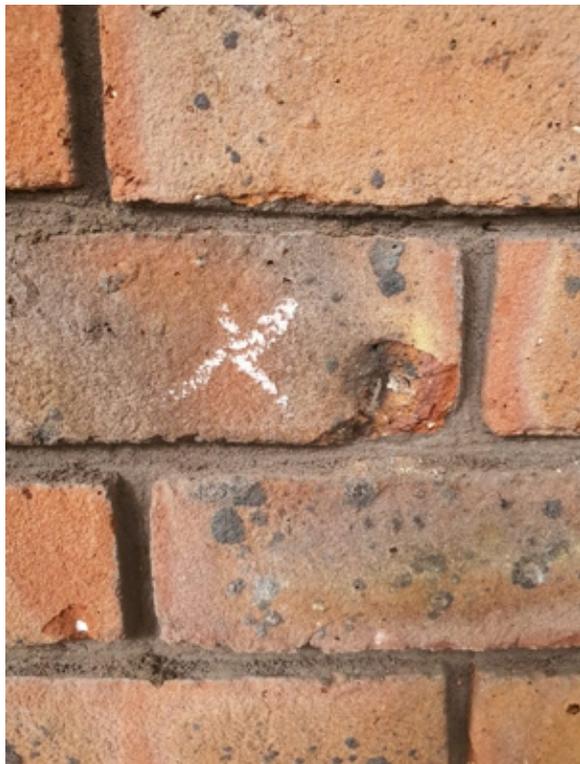
Damaged caused by lime blow can be seen next to the 'X' marked in the brickwork

If lime is present in clay bricks when they are fired, then it converts to calcium oxide. When calcium oxide mixes with water it begins to slake in a highly vigorous process known as lime blow, which can eventually lead to the face of the brick erupting.

Brickwork at a fairly new housing estate in the UK was suffering from severe lime blow caused by coming into contact with rainwater. A building firm were asked to find a cost effective method for restoring the brickwork by filling in the damage.

Sylmasta recommended the use of epoxy putty. A trial run saw Magic Sculp mixed with brick dust, before the builders decided to repair all bricks with **Sylmasta AB Original Epoxy Putty**.

AB Original was mixed by hand and pressed into the brickwork, where it filled the damaged area. Once applied to the wall but whilst still soft, the putty was wetted with water and dust collected from the brick.

This dust was then pushed into the putty, creating a material which blended seamlessly with the colour of the brick. To give the putty an identical texture to the brick, it was then spittled with a wire brush.

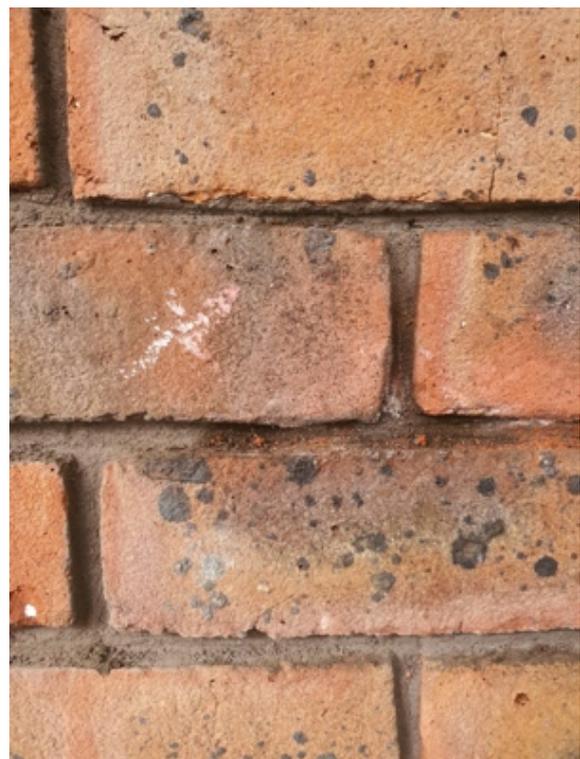
The application was so effective that it was all but impossible to tell afterwards where the brick had been repaired.

AB Original mixed with brick dust created a seamless repair with the brick
