SUPERFAST Case Study

Repair of Rust Holes on a Classic Car

When rust holes developed on a classic car, the owner used Superfast Steel Epoxy Putty as a cost-effective, quick and easy way to repair the problem

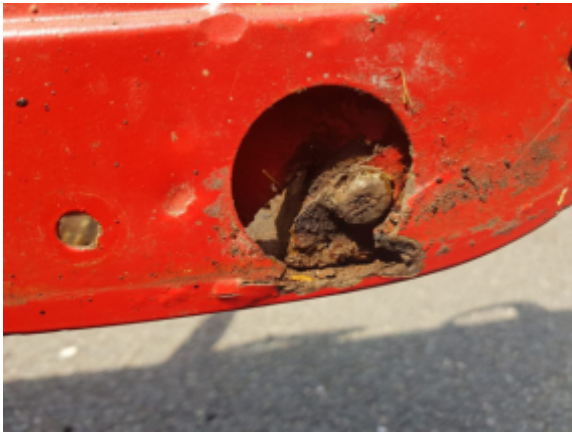
Corrosion had eaten away at the metal frame of the car, causing rust holes to develop around a screw

Corrosion had eaten away at an inside section of the car door where the window mechanism was anchored, causing it to fail.

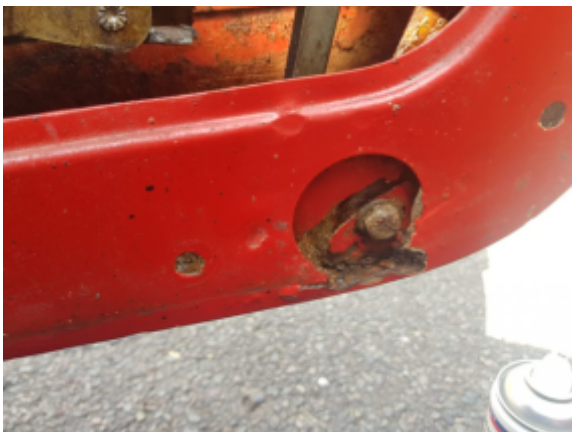
Moisture Repellant Spray was used to drive moisture and grease from the hole before the metalwork was further cleaned via the removal of dirt, grime and rust

Moisture Repellant Spray was applied to drive grease and moisture from the hole. Dirt, grime and rust were removed to clean the damaged area.

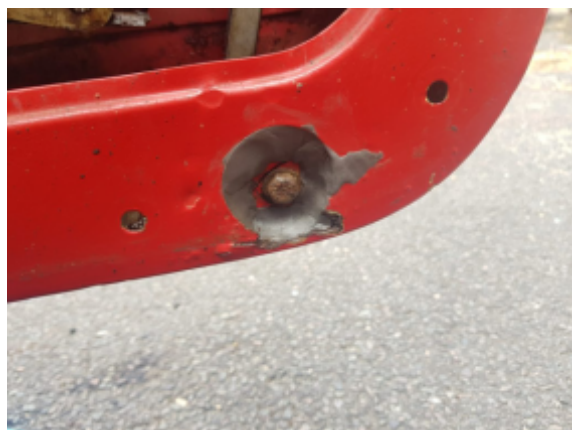
Superfast Steel was pushed into the hole and shaped around the screw, filling the damage. Once cured, it was filed and painted red to match the car frame

A **Superfast Steel Epoxy Putty Stick** was then used to fill the hole. The required amount of putty was cut from the stick and kneaded by hand. Whilst soft, the putty was pushed into the hole, where it was shaped and moulded around the screw.

Within 10 minutes, it had begun to harden into a material sharing the look and feel of steel. Full properties were reached in one hour, after which he putty was filed and painted red to appear uniform with the rest of the car frame.
