SYLWRAP Case Study

Libya Water Supply Pipes Live Leak Repair

Above and below ground water pipes servicing a town in Libya undergo live leak repair to seal cracks through which high levels of water were escaping

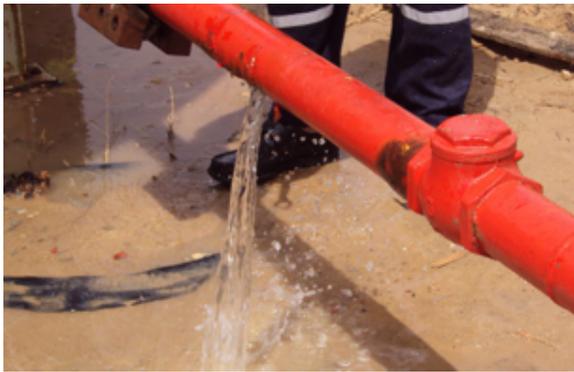
Significant levels of water were escaping the above-ground section of pipe at 5 bar pressure from a longitudinal split

When a longitudinal split developed in an above-ground pipe and water began escaping at 5 bar pressure, it was decided to fix both leaks.

For the above-ground pipe, **Wrap & Seal Pipe Burst Tape** was wrapped along the length of the split. Multiple Tapes were applied over each other until no more water was leaking.

This indicated the repair had reached the required pressure resistance. A **SylWrap HD Pipe Repair Bandage** was then applied to reinforce and protect the initial sealant.

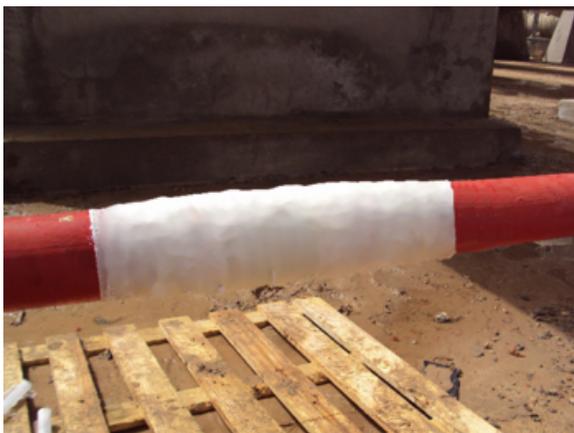
The above-ground section having been successfully repaired using Wrap & Seal and then overwrapped with SylWrap HD

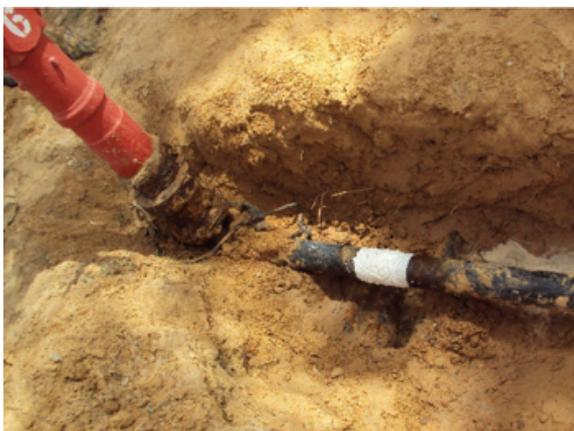
The 100mm pipes were part of the water supply network to the town of Brega, operating at 5 bar pressure. An underground section was leaking, noticed through visible signs in earth surrounding the pipe.

A trench was dug with enough clearance to reach the below-ground section of pipe, which was then repaired using Wrap & Seal and SylWrap HD

A trench was dug to reach the below-ground section with enough clearance to wrap both Wrap & Seal and SylWrap HD around the pipe. The small crack was easily arrested.
