Sylmasta AB Case Study

Protection of Wooden Entrance Gates Against Rot

After Storm Arwen destroyed wooden entrance gates at an estate in Scotland, robust replacements were built with Sylmasta AB providing rot protection

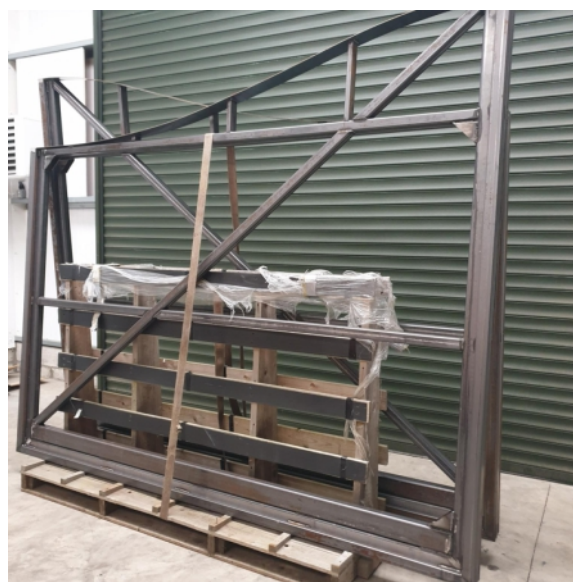
The steel frame to which the slats would be fitted

The destruction of the previous gates led the estate to fabricate a strong steel frame capable of withstanding extreme weather for their replacements, to which wooden slats would be attached via stainless steel self-tapping screws.

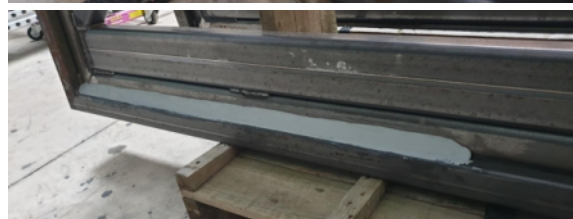
Putty formed into a bevelled edge to prevent water gathering at the base of the frame

At the base of the frame sat an area where rainwater could gather with no means of escape other than evaporation, potentially causing future rotting to the bottom of the slats.

To prevent water pooling, the estate came up with the ingenious idea of using epoxy putty to create a bevelled edge between the base and the frame.

This edge would divert water onto the ground, ensuring no contact with the wooden slats. The bottom of the slats were also bevelled, creating a 5mm gap through which water could pass.

Sylmasta AB Original was chosen for its waterproof qualities and two-hour work time, enabling the putty to be formed into the required edge without the threat of premature curing.

AB Original was mixed by hand and easily adhered to the steel frame. Its ultra-smooth finish created the perfect run off. The frame, slats and epoxy were coated with a beige coloured protective paint, making the structure appear to be made of wood.

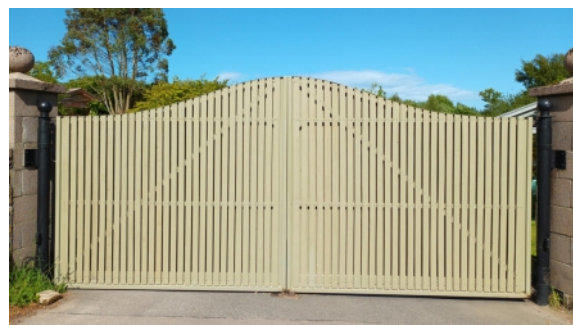
The gates were painted beige to appear uniformly made of wood and then installed at the entrance

Since being installed, the new gates have coped with every kind of weather Scotland has thrown at them. There are no signs of rot to the slats and this fine piece of engineering will last a long time.
