SYLWRAP Case Study

Boat Engine Leaking Rubber Hose Repair

A rubber hose connected to a boat engine undergoes repair after developing a pinhole leak in an area of the vessel which was extremely difficult to access

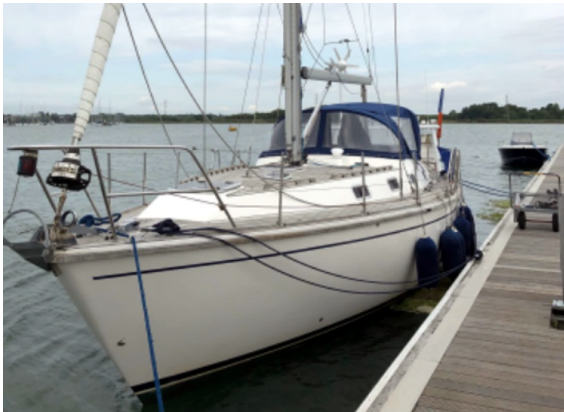
The boat could not sail safely whilst the hose leaked

The hose carried water as part of the cooling process, which was spraying out of the pinhole at high pressure whenever the engine was in service.

Repairing this dangerous leak was made difficult as the hose was in a confined space below deck, surrounded by other pipes and engine components.

First, the pinhole was sealed with **Superfast Steel Epoxy Putty**. The putty was kneaded by hand and applied over the leak area whilst soft.

It was then overwrapped with a **SylWrap HD Pipe Repair Bandage**. As SylWrap HD was wrapped and smoothed around the hose, it forced the putty further into the pinhole as it cured, completely sealing the leak.

After both Superfast Steel and SylWrap HD had set, a permanent repair with pressure resistance up to 30 bar and temperature resistance up to 200°C had been created.

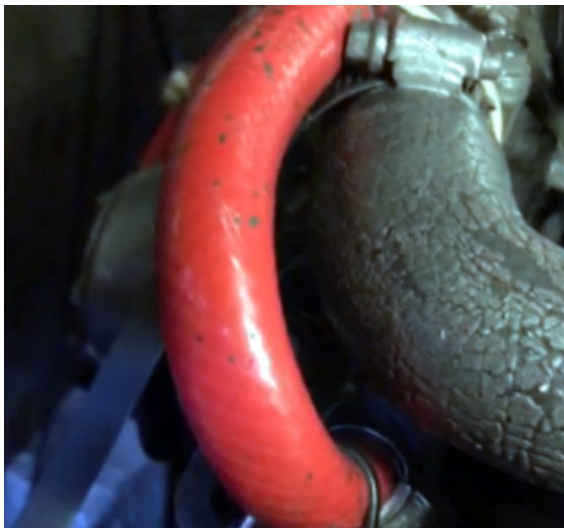
The pinhole was on a section of red coloured rubber pipe where access was severely restricted

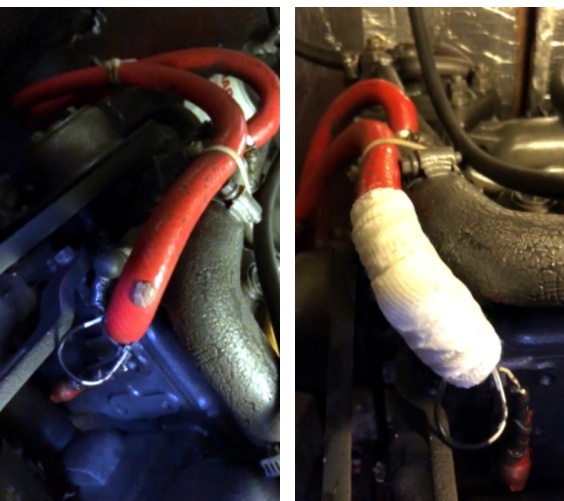
Superfast Steel was applied to the pinhole, followed by a SylWrap HD Bandage to seal the leak
