# SYLWRAP Case Study

## Oil Refinery Repair Leaking Water Cooling System

An oil refinery carry out a significant pipe repair programme after microbially induced corrosion caused welded joints in the water cooling system to fail

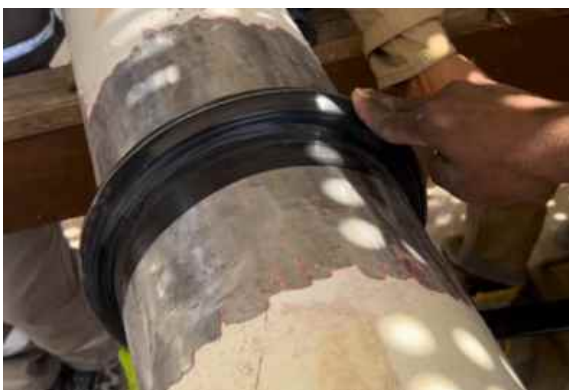
The stainless steel water cooling system was meant to have a lifespan of 50 years, yet numerous welded joints had started leaking after less than half that time.

Microbially induced corrosion (MIC) was found to be the cause, attacking the pipe interior where welding had damaged the stainless steel's passivation layer.

*Multiple Wrap & Seal applied to leaking welding joints built repairs capable of holding 10 bar pressure*

Over 1,700 **Wrap & Seal Pipe Burst Tape** and 500 **SylWrap Pipe Repair Bandages** were sent to the refinery. Sylmasta also flew to the Middle East to train installers and supervisors on using the products.

Whenever a leak now develops, **Wrap & Seal** and **SylPad Pressure Resistance Multiplier** are on-site and ready to make online repairs capable of holding the 10 bar pressure the system operates at.

After sealing, each welded joint is overwrapped with SylWrap Bandage for a permanent, reinforced repair.

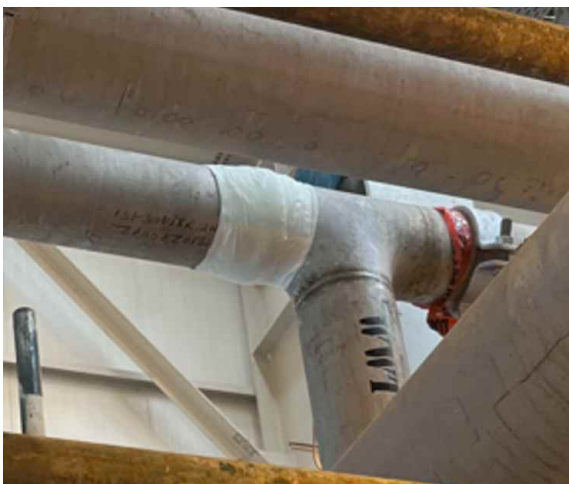
Since Sylmasta's visit, the refinery have repaired numerous leaks - including to overhead and difficult-to-access sections of pipework in constrained spaces.

*Repairs were reinforced with SylWrap Bandage - and were made to difficult sections of overhead pipe*
