# WearShield Case Study

## Copper Mine Damaged Pump Housing Repair

Pump housing at a copper mine left damaged by years of river water extraction undergoes repair after replacement was deemed too expensive

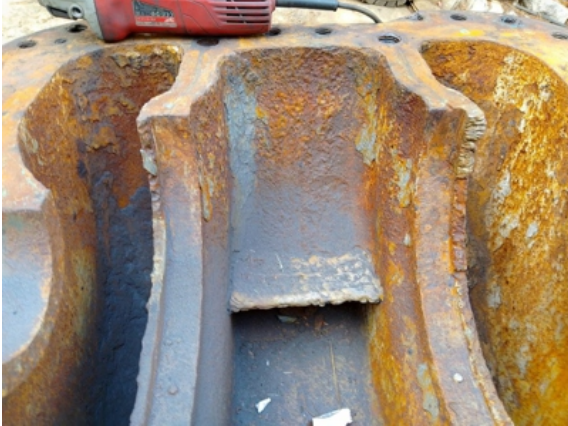
The pump housing was heavily damaged by years of extracting water containing silt, sand and other debris

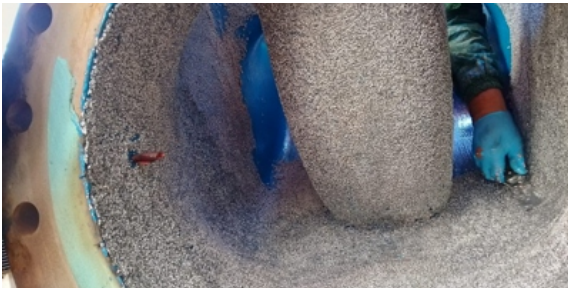
WearShield created a 30mm thick alumina-reinforced protective shell over the pump housing

An initial coating of Cermaic Brushable sealed the metalwork. WearShield was applied on top of the Ceramic Brushable, forming a 30mm thick alumina-reinforced protective shell all over the pump housing.

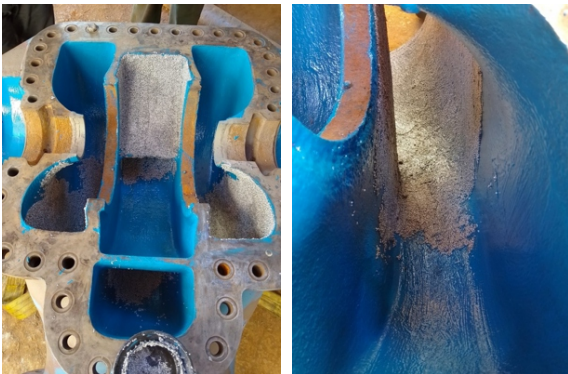
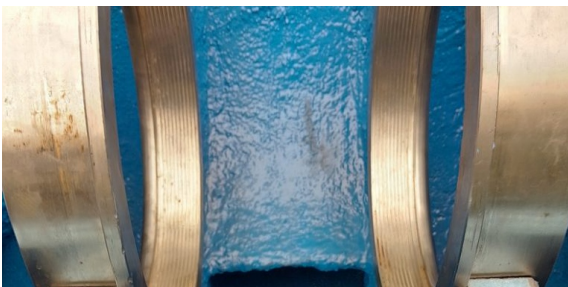
Top coating WearShield with Ceramic Brushable left an ultra-smooth, low-friction finish to the repair

Because the dense alumina bead structure of WearShield makes the cured material rough, it was top coated with more Ceramic Brushable.

This gave the repair an ultra-smooth, low-friction finish to improve flow through the pump housing, making it more efficient when put back into service.
