Epoxy Putty Case Study

Scottish Dam Concrete Flood Defence Wall Repair

Gaps left when an ineffective sealing compound washed out of a new flood defence wall are resealed at a multimillion pound dam project in Scotland

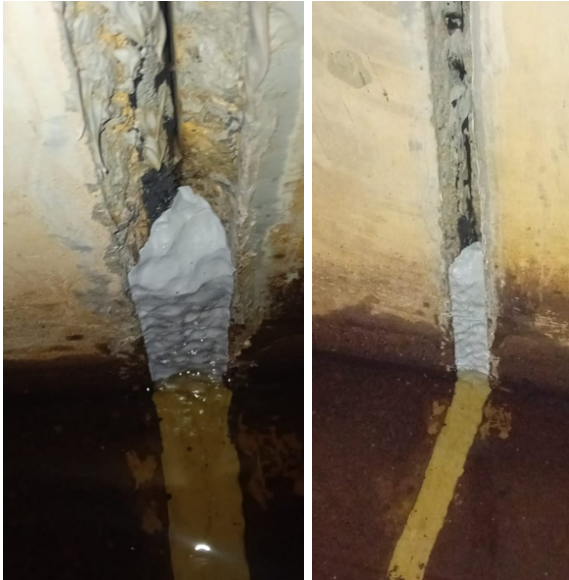
The original sealing compound between concrete slabs had washed out of the flood defence wall, with the resulting gaps packed with AB Original

The walls were made of concrete slabs sealed by a grout compound. Not long after completion and flood water began washing away the grout, leaving huge gaps and large-scale leaks in one section of wall.

45kg of AB Original was delivered to site in 200g sticks. Each stick was mixed by hand and forced into the gaps between slabs whilst soft.

Once cured, the putty formed a rock-hard, watertight material much more effective than the original grout compound, completing a permanent repair.

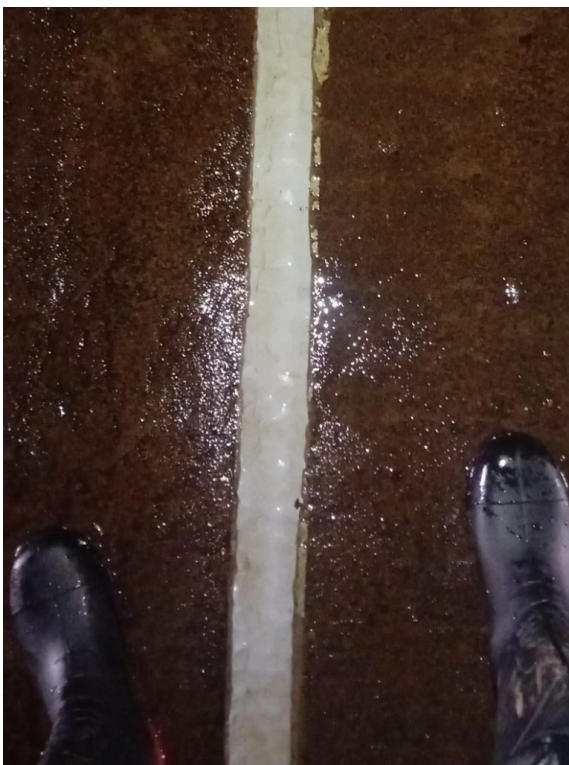
Gaps in the concrete floor submerged by flood water were also sealed thanks to the underwater curing properties of AB Original

With its underwater adhesion properties, AB Original easily bonded to the saturated concrete and parts of the flood defences submerged by escaping water, including gaps in the floor.
