SUPERFAST
TITANIUM

Case Study

Narrowboat Engine Heat Exchanger Manifold Repair

A narrowboat owner makes a high temperature repair to a 15mm x 15mm hole which appeared in the engine heat exchanger manifold of the vessel

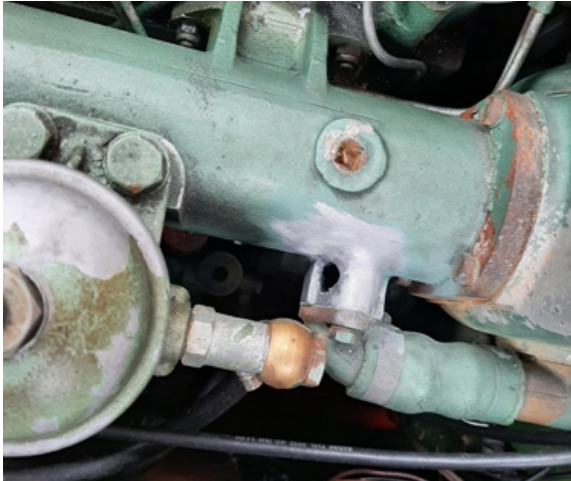
The narrowboat owner noticed the 15mm x 15mm hole in the engine heat exchanger manifold whilst moored on a canal 30 miles from London

Whilst moored on a canal 30 miles north of London, the narrowboat owner noticed a 15mm x 15mm hole had appeared in the heat exchanger manifold.

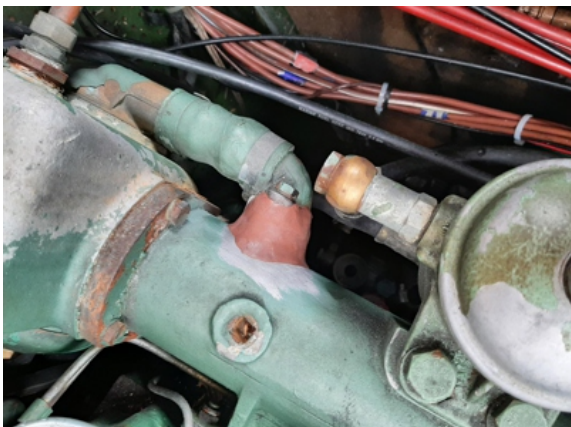
The hole was sealed by total encompassment with Superfast Titanium

The putty was mixed by hand and applied over the mesh and surrounding area. It was pushed firmly onto the manifold for maximum contact, smoothed off with a little water and then left to harden.
