Liquid Metal Case Study

Industrial Plant Anti Slip Flooring Installation

PepsiCo use Liquid Metal as a cost effective means of laying new and replacement anti slip flooring to 12 different areas of their plant in Chile

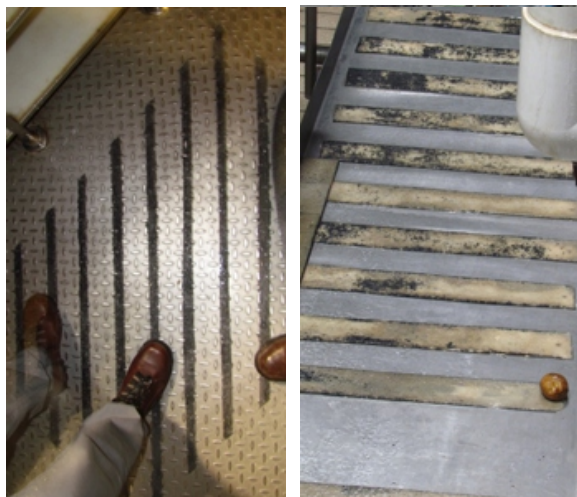
Existing anti slip surfaces at the plant needed to be replaced having become worn and ineffective

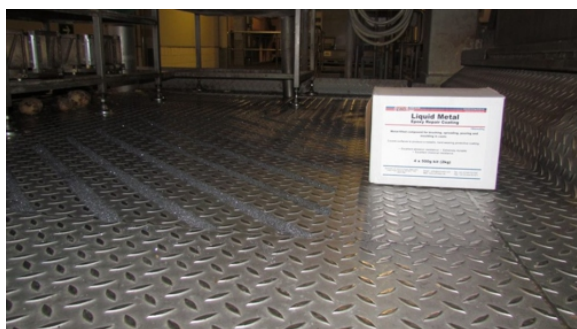
Liquid Metal was painted onto the surface in strips marked with masking tape and silicone carbide grit sprinkled on top

Masking tape was used to mark out where anti slip strips were required. The surface was painted with Liquid Metal, silicone carbide grit was sprinkled over the top, and then the masking tape was removed.

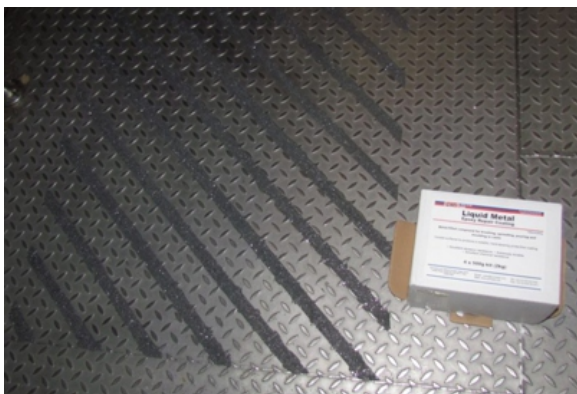
Once cured, Liquid Metal permanently bonded the grit to the flooring, creating an anti slip surface

Once Liquid Metal had cured to form a metallic layer, the grit was permanently bonded to the floor, creating a new anti slip surface.
