Liquid Metal Case Study

Anti Slip to Protect Helicopter Workers

Anti slip surfaces are created on the legs of the Puerto Rico Power Authority's helicopter fleet to protect workers standing on the skids whilst working

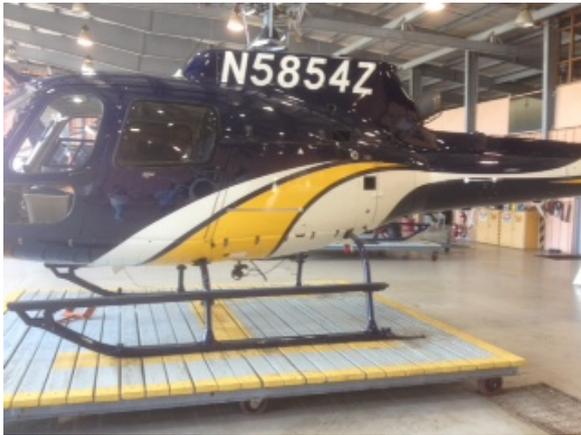
A helicopter belonging to the Puerto Rico Power Authority. Some maintenance jobs involved workers standing on the legs of the helicopter, which had anti slip tape applied as a means of protection

Some maintenance tasks carried out by the fleet of helicopters required workers to stand on the metal legs. These legs had anti slip tape applied.

The harsh environments the helicopters operated in meant new tape had to be applied once a month. This was time consuming and costly.

There were also concerns about the safety of the tape. The frequency with which it became worn and damaged led the Power Authority to seek a longer term, more trustworthy alternative.

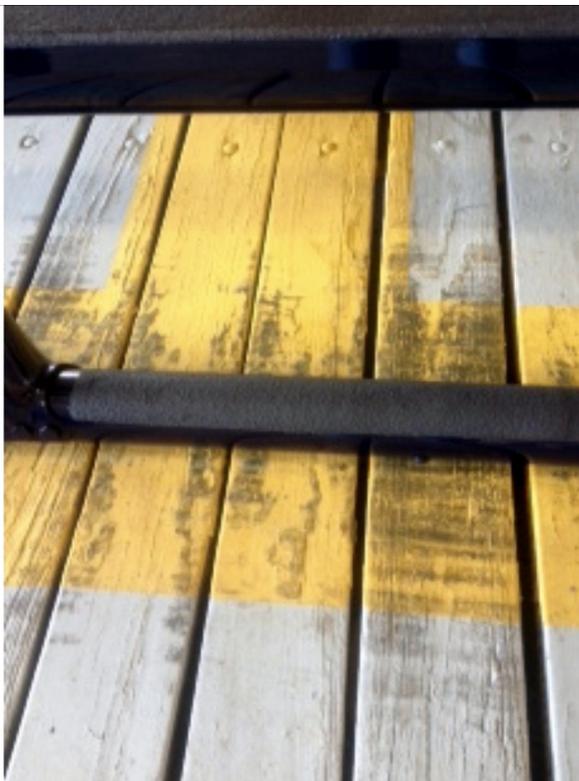
Liquid Metal was coated onto the legs and silicon carbide deposited over the top. Once the epoxy had cured, the grit was permanently bonded to the skids to create a long term anti slip solution

Sylmasta suggested coating each helicopter skid with **Liquid Metal Epoxy Coating** and then applying silicon carbide grit to the wet surface, creating a robust anti slip surface.

Liquid Metal offers high strength adhesion to all materials. The coating was applied across the top of each skid, forming a new metallic layer.

Silicon carbide was then deposited over the epoxy, completely covering the skid. Once Liquid Metal cured, the grit was permanently bonded to the helicopter leg.
