SYLWRAP CR

CORROSION PROTECTION WRAP

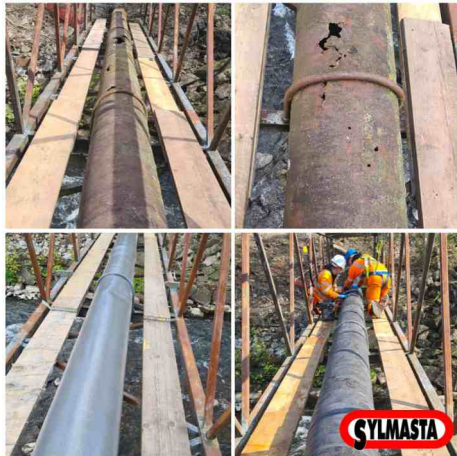
Corroded 20-Metre Long Steel Pipe Bridge Reinforcement

The 300mm steel pipe crossed a river over a 20-metre long bridge operated by Welsh Water. The pipe was covered in corrosion, which had eaten through in places.

Welsh Water instead opted to refurbish the pipe. Fibreglass patches were layered over the cracks before the structure was painted with **Liquid Metal Epoxy Coating**, which created a new, hard-wearing, smooth, metallic exterior surface for the line.

SylWrap CR was then wrapped along the pipe, forming a rock-hard, impact resistant protective shell. The repair was completed in three days, costing under £12,000.

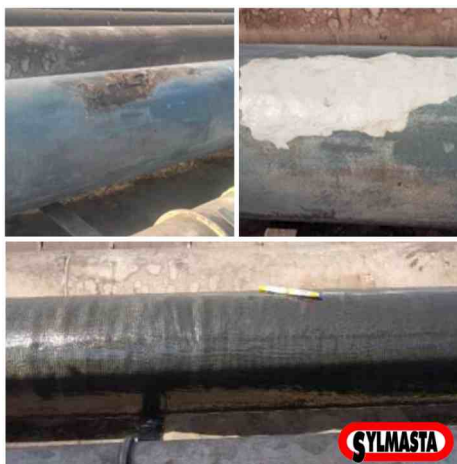
Industrial Site Rebuild and Reinforce Corroded Steel Pipe

A two-metre section of pipeline at an industrial site had been badly weakened by a 600mm patch of heavy corrosion. It was now only a matter of time until the corrosion ate through the brittle steel. When this happened, the line would have to be shut off for either a complex leak repair or a replacement section to be fitted.

Sylmasta AB Original Epoxy Putty was applied to the weakened section. It filled in all the imperfections and pitting caused by corrosion and returned the exterior of the line back to its original thickness.

To reinforce the repair and further protect the pipe from future corrosion, SylWrap CR was then wrapped around the entire length. A follow up five years later revealed the reinforcement was still in excellent working order with no sign of deterioration.
